# **Curtis Bay Piers Coal Facility Explosion Investigation**

**Cause & Origin Evaluation**

CSX Transportation

29 July 2022

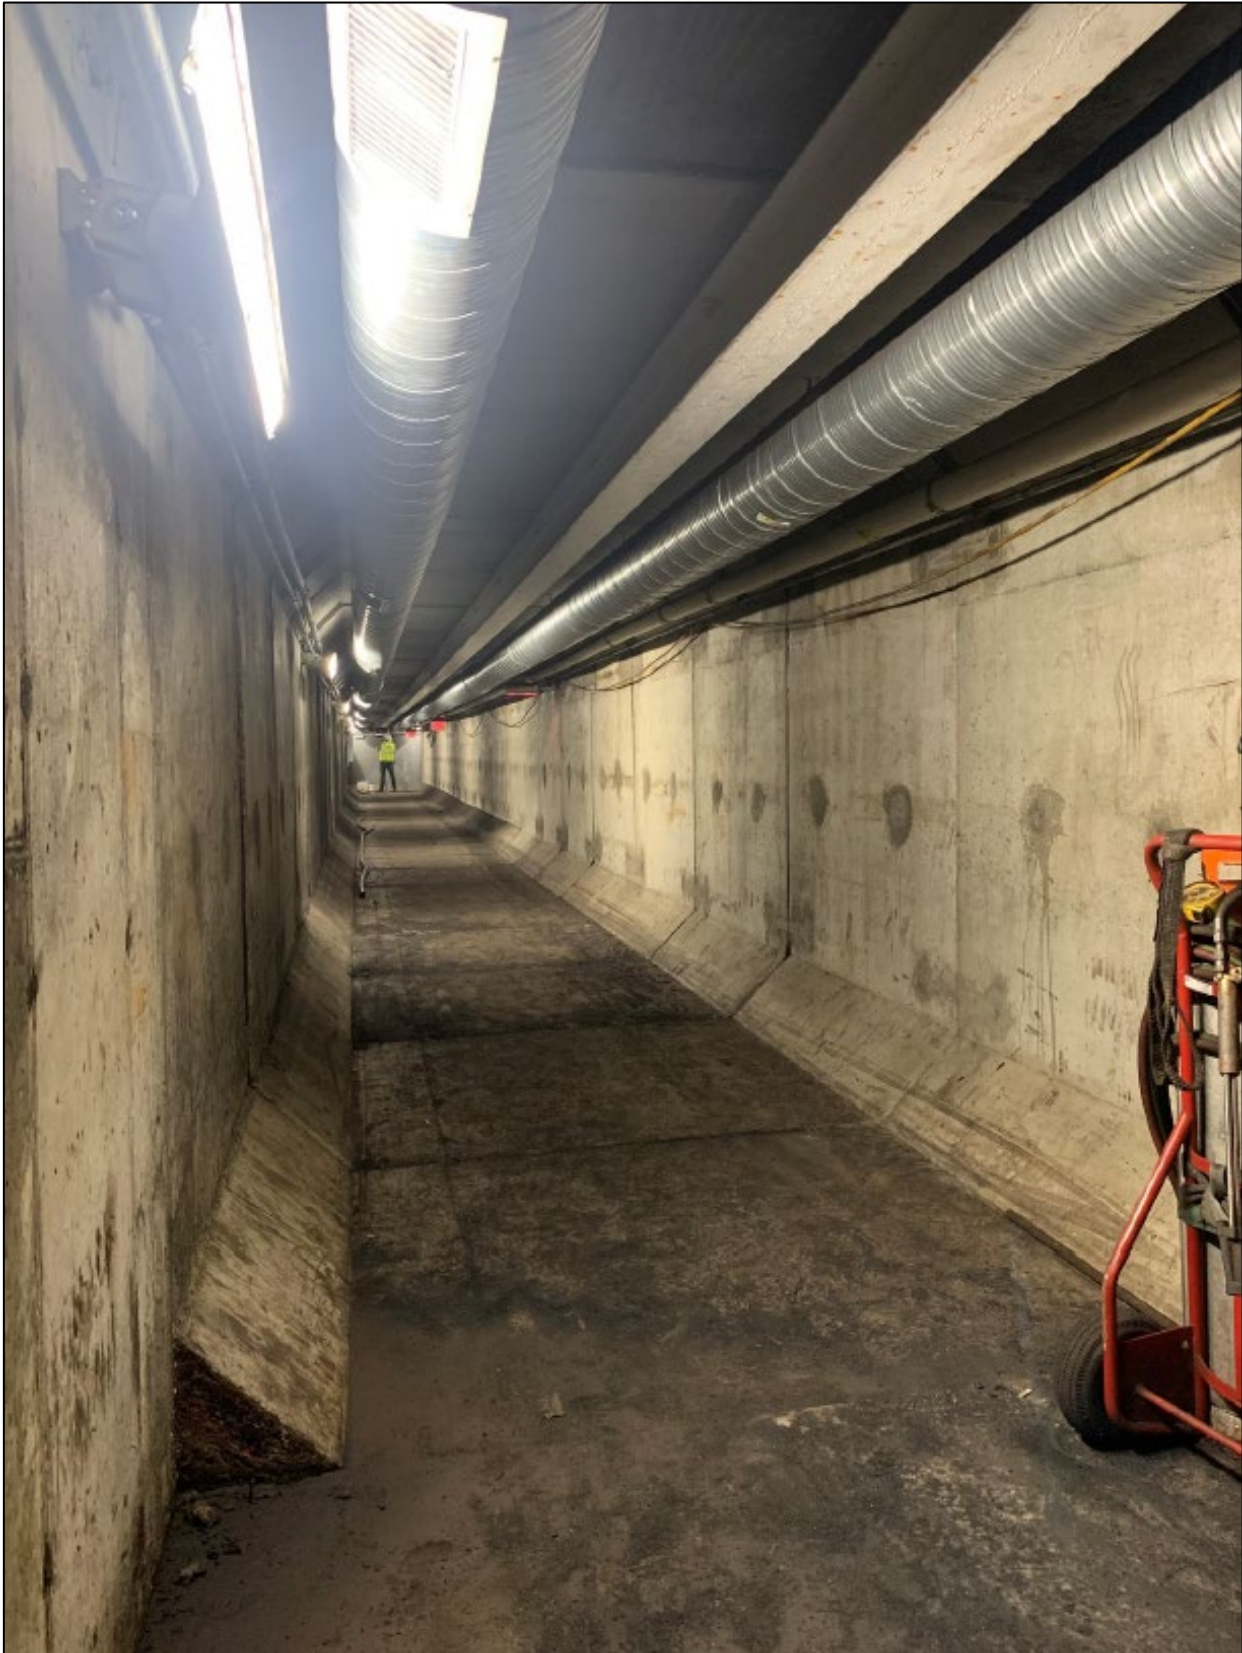
Figure 2.2.1. North Escape Tunnel as seen on July 9, 2020.

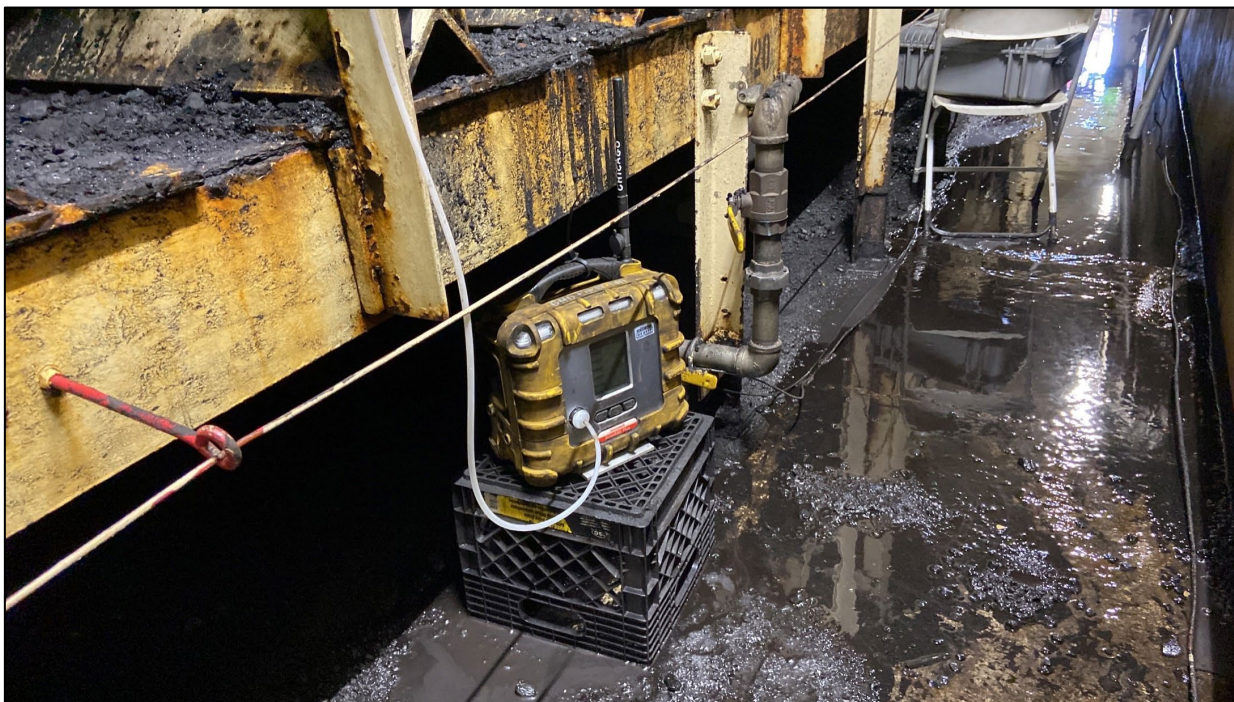
Figure 5.6.1. Monitor on floor of South Reclaim Tunnel with sample tube leading to higher elevation

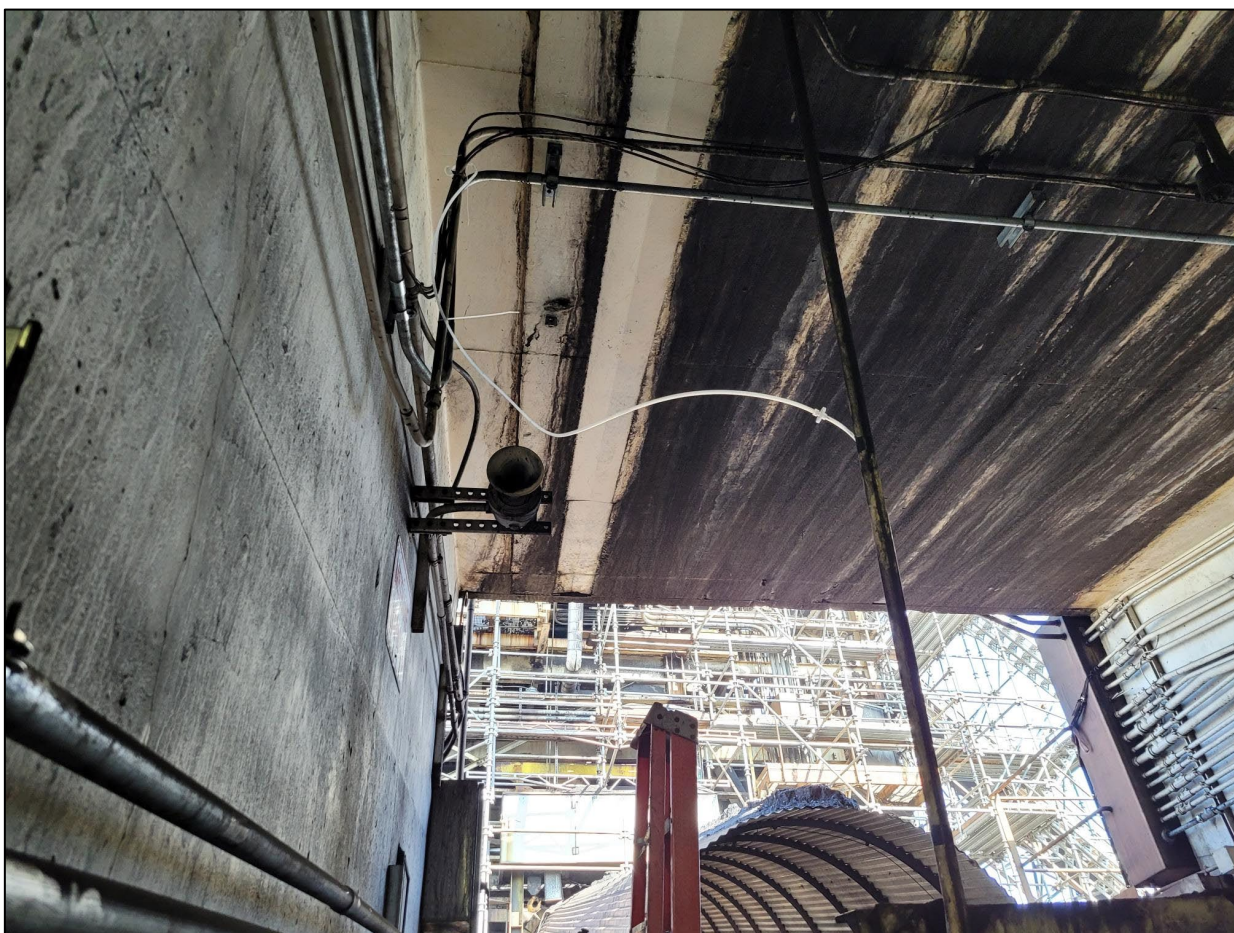
Figure 5.6.2. Monitoring high location near top of tunnel using tubing.

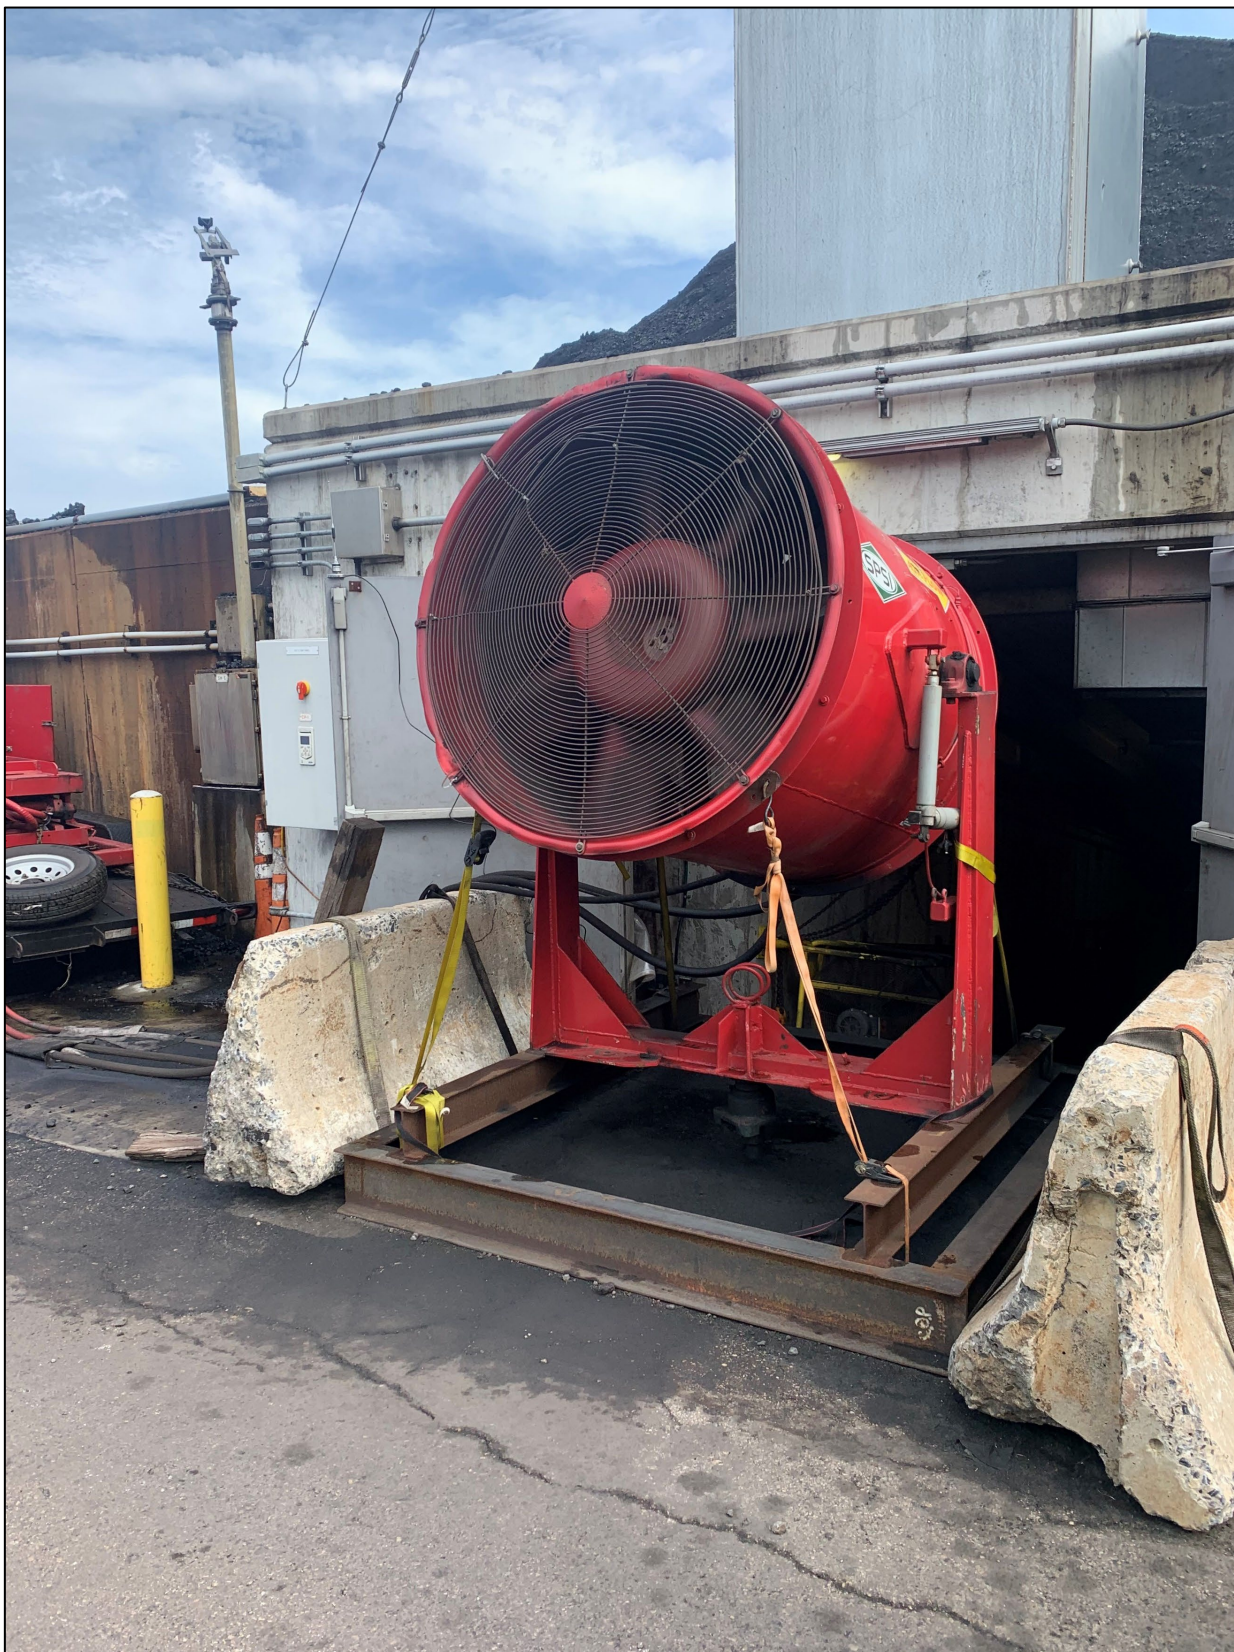
During the restart of the South Reclaim Tunnel, CSXT installed a temporary fan capable of providing up to 100,000 cfm airflow. At normal idle, the fan provides 80,000 cfm airflow, which would yield a theoretical linear flowrate of 500 feet per minute through the South Reclaim Tunnel. The mining industry uses a layering number analysis method to ensure adequate ventilation in underground coal mines. Typical linear velocities that are recommended for places where workers are present, and to prevent methane layering near ceilings or creating pockets in tunnels are reported to be 200-600 feet per minute.<sup>1,2</sup> This is consistent with observations in the South Reclaim Tunnel.

Figure 5.6.3. Temporary ventilation fan installed at south portal of South Reclaim Tunnel.

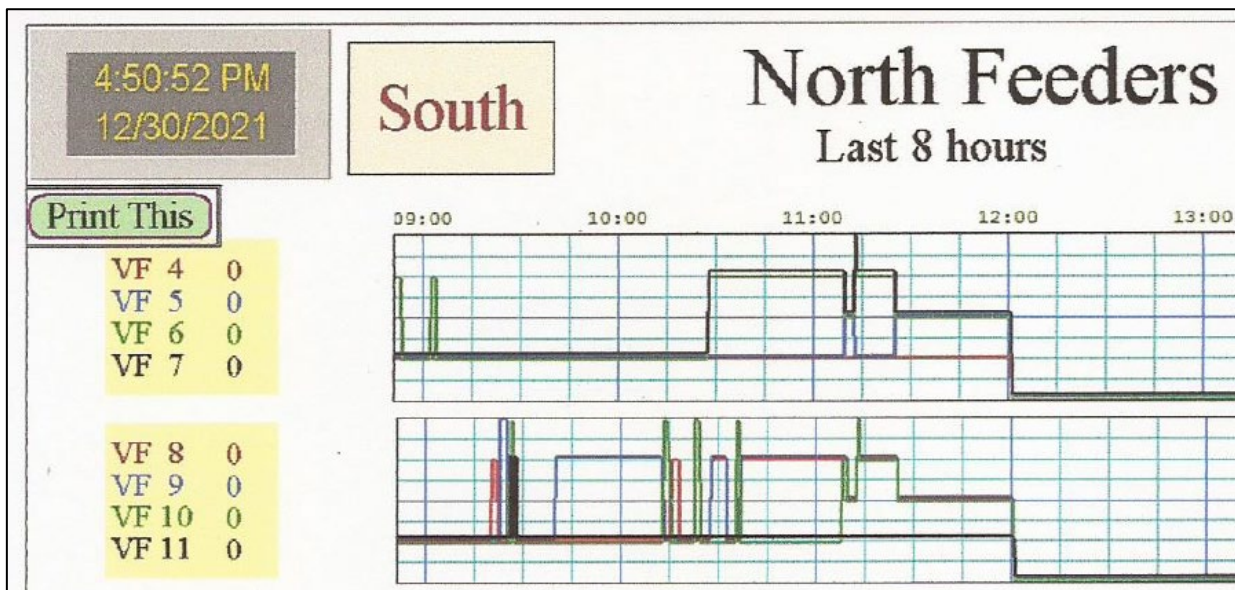
Additional detail was provided by Bruno Reyntjens of PCMA Systems, Inc. regarding the control system operation of the feeders during the time of the explosion. He reported that no feeders were being turned off or turned on in the moments before the explosion. A graph of the system is provided in Figure 5.7.1 below, with the intermittent activation of VF-5 through VF-10 visible on the graph.

Figure 5.7.1. Graph of feeder operation leading up to the time of the explosion.

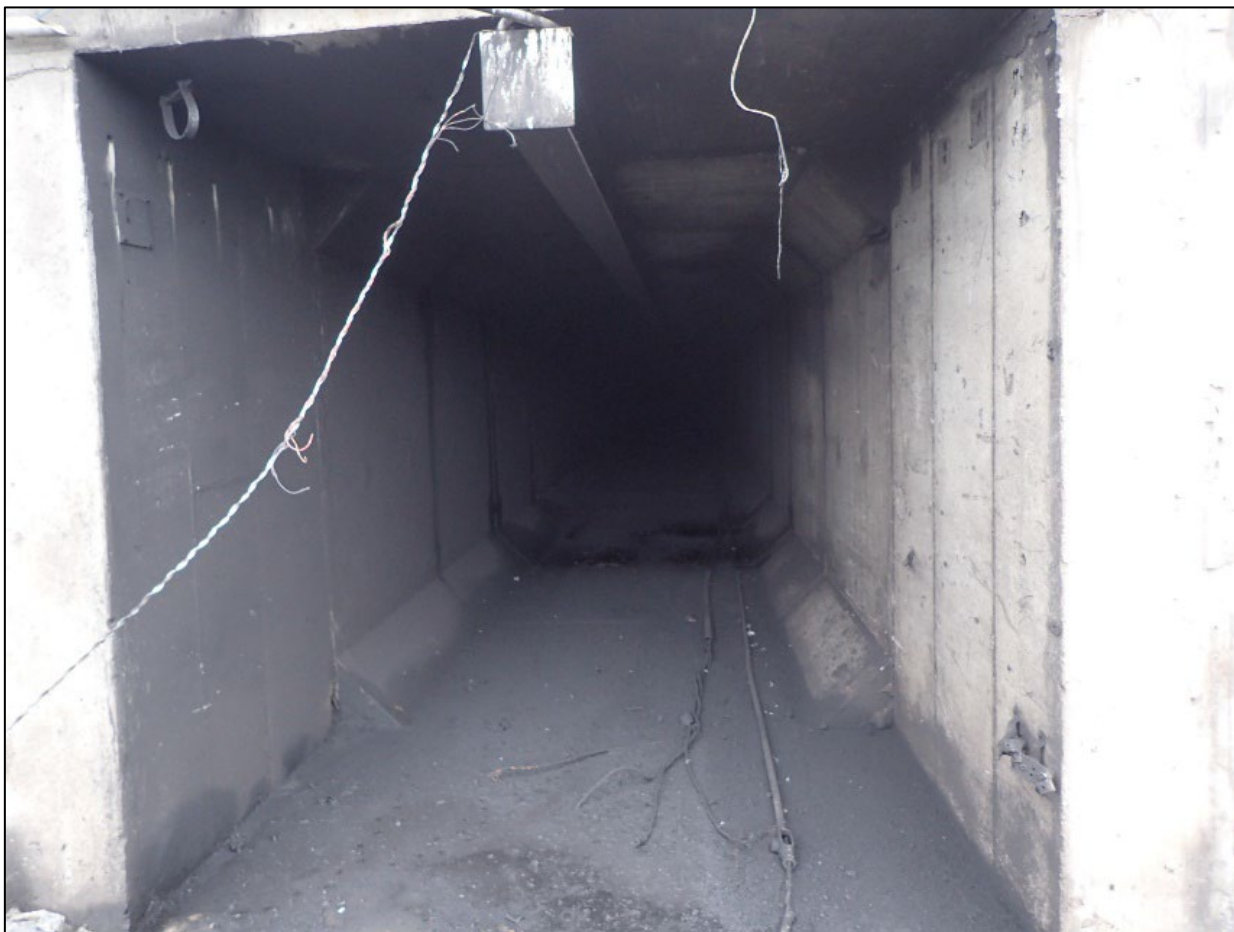
The pressure wave traveling north in the tunnel encountered the wall at the north end of the tunnel, and was magnified by reflection, as well as the additional confinement at the junction due to tunnel geometry (for example, an approximately 2-foot drop in elevation between the floor of the escape tunnel and the floor of the main tunnel). Pressure built slowly due to the confinement by the vestibule enclosure at the west portal of the escape tunnel until it failed outwards and released the pressure wave, in the absence of combustion. This release is partially evidenced by the presence of coal dust on the north wall of the escape tunnel, and absence of coal dust on the south wall of the escape tunnel, as depicted in Figure 6.2.1.

Figure 6.2.1. View east into escape tunnel portal. North wall (left in picture) is black; south wall is not.

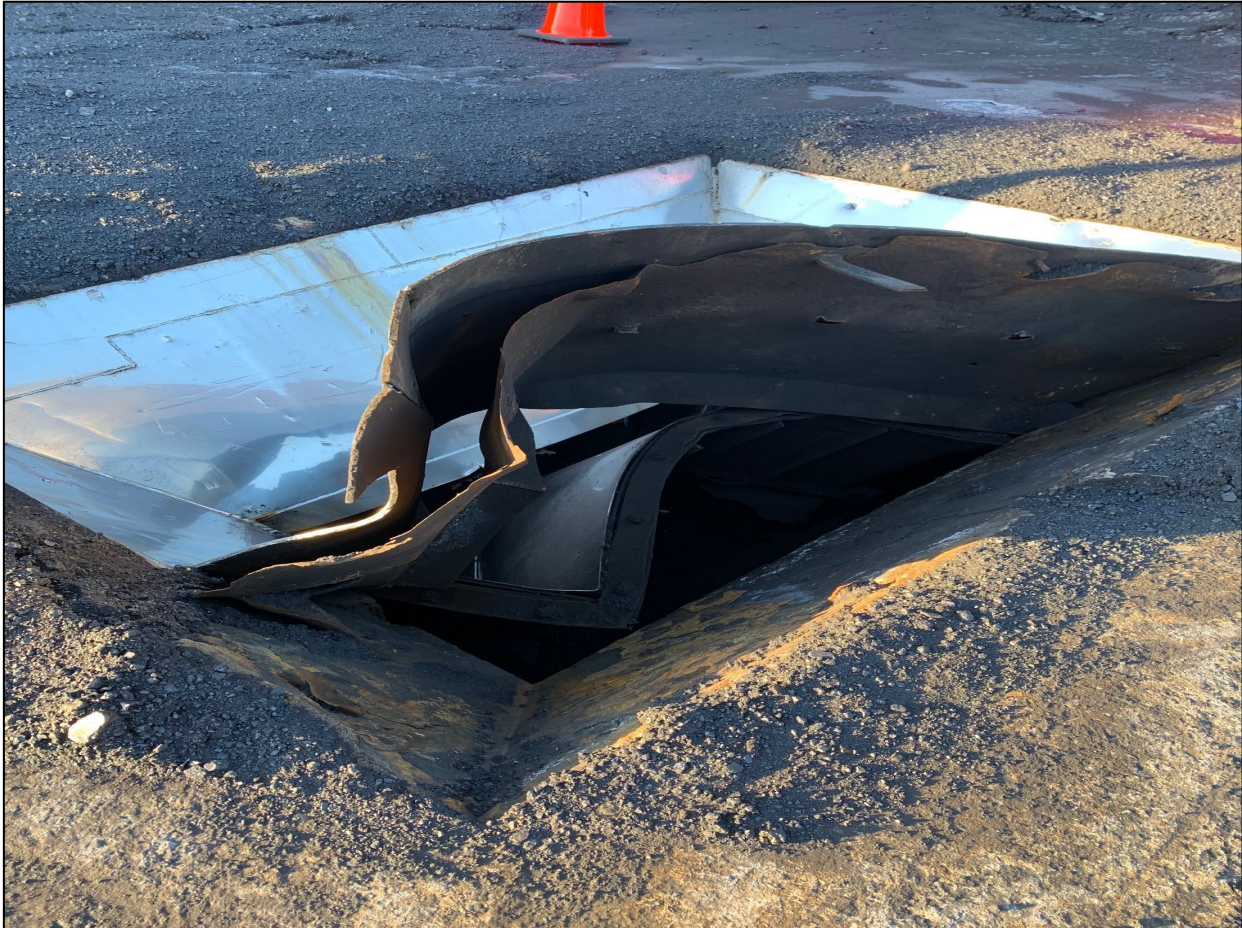
The pressure wave traveling south towards the south portal of the main tunnel built in intensity and picked up additional fuel in the form of dust and additional methane being released by the coal. A tertiary pressure front likely built near VF-21, which was thrust upward and outward through its feeder hole. Figure 6.3.1 shows the surface picture of VF-21, and Figure 6.3.2 shows the feeder from inside the tunnel. This pressure front led to the combustion of a large amount of fuel, and the resulting fireball that exited the south portal.

Figure 6.3.1. Feeder hole for VF-21 from the surface of the coal transfer yard.

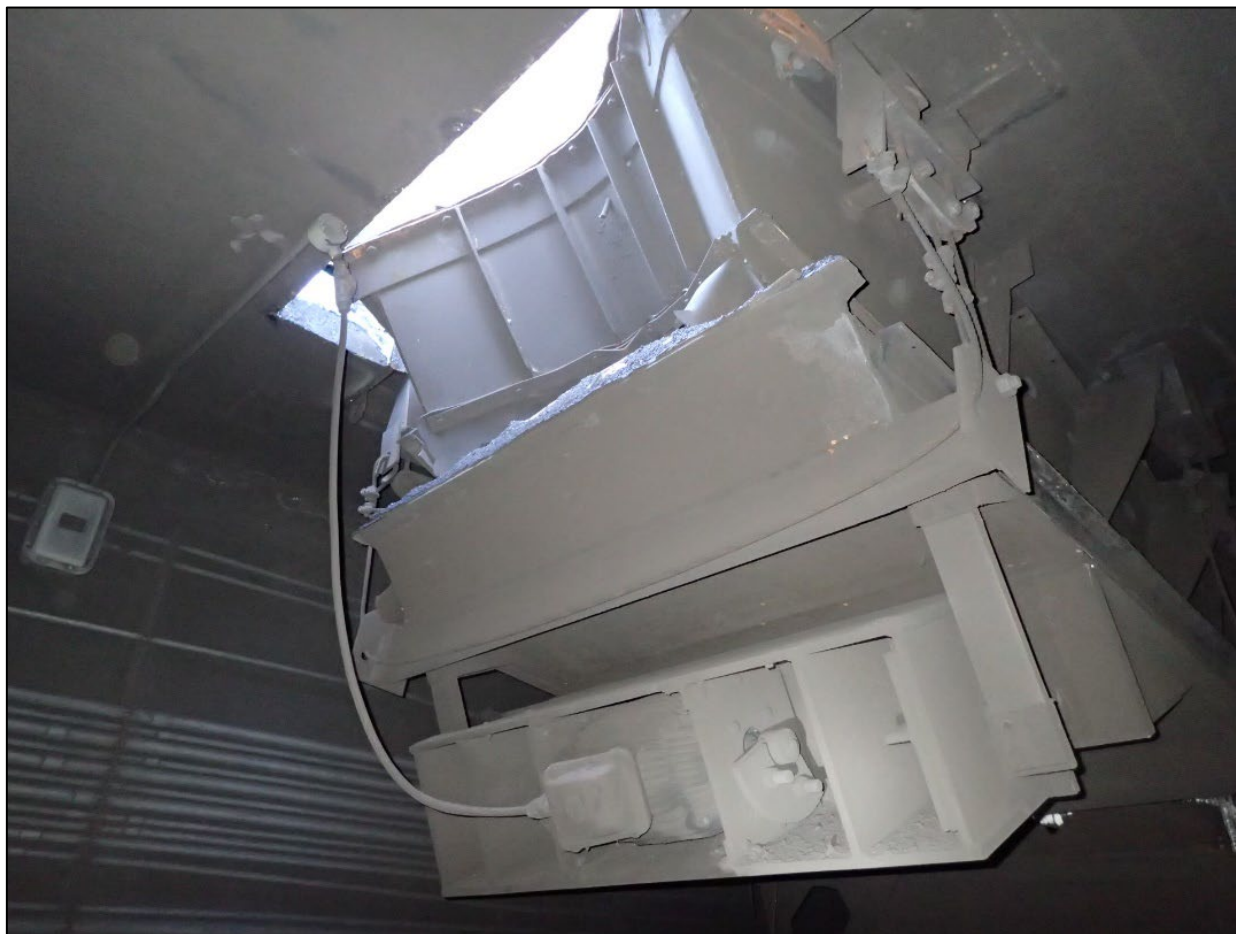
Figure 6.3.2. Feeder 21 from beneath the feeder hole, in the North Reclaim Tunnel.
