Re: EQT Phoenix Resources Site in Duncan Township, Tioga County, Pennsylvania

Facts Related to the S-Pit Failure and Chronology

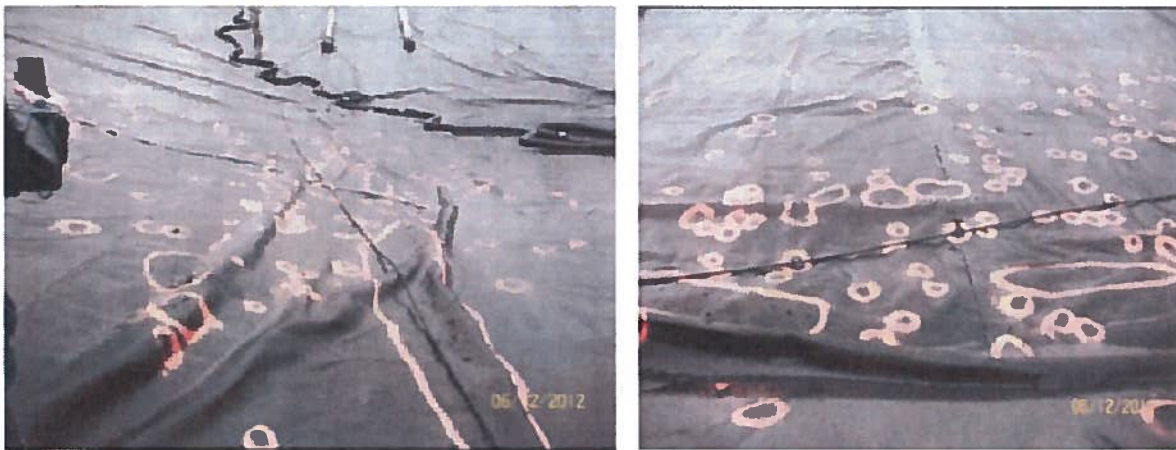
Photos with S-Pit liner holes circled, taken during the June 12, 2012 PA DEP Inspection (Attachment 10).

Although EQT first indicated that the liner was torn in 6 or 7 places, subsequent drainage of the pit revealed up to 100 holes and tears in the bottom and sidewalls of the liner. In a Site Characterization Plan submitted to PA DEP on June 22, 2012, EQT estimated that 1,362 barrels (or approximately 57,000 gallons) of flowback were discharged from the S-Pit between April 1, 2012 and June 1, 2012 (Attachment 2, p.3). EIP could not locate a PA DEP document estimating or discussing the volume of the release.²³ Whether 57,000 gallons or substantially more, these discharges were to groundwater, surface water, and unprotected soils. Following aerial inspection, PA DEP and EQT met on site on August 14, 2012 to discuss and view areas of distressed vegetation. Four multi-acre, distinct areas of distress were noted, as depicted in Map 2, below: 1) an area west of the S-Pit surrounding the Upper and Lower West Seeps, along and including an UNT to Rock Run; 2) an area northeast of the S-Pit surrounding the North Spring; 3) an area southeast of the S-Pit and due east of the S-Pad; and 4) an area further southeast of area # 3, above, that surrounds Danzer Seep #1 and Danzer Seep # 2 (both of which discharge to Rock Run).

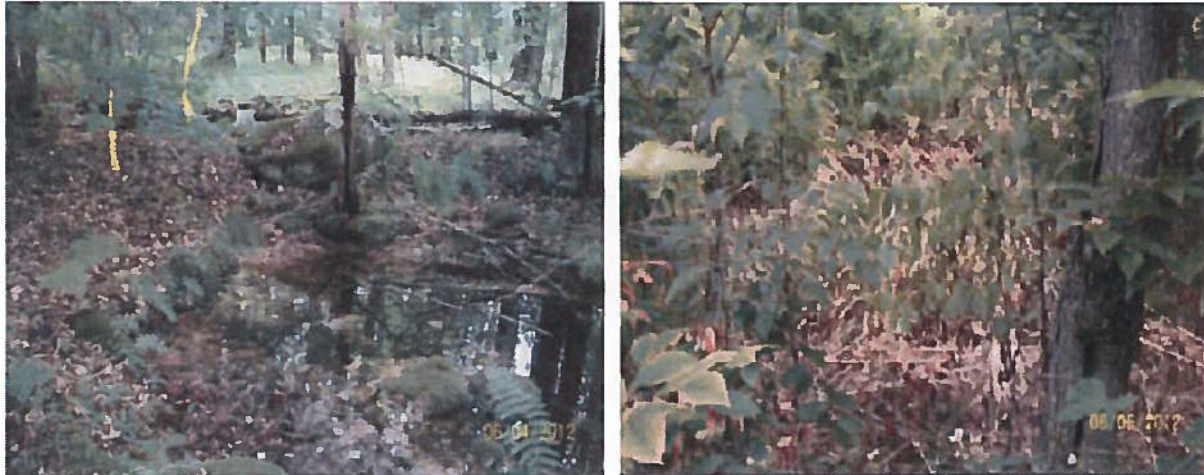
Photo on left shows distressed and dying vegetation in Distressed Area # 1 (West Seeps), taken during the June 4, 2012 PA DEP Inspection (Attachment 13). The photo on the right shows distressed and dying vegetation in Distressed Area # 2 (North Spring), taken during the June 5, 2012 PA DEP Inspection (Attachment 14).

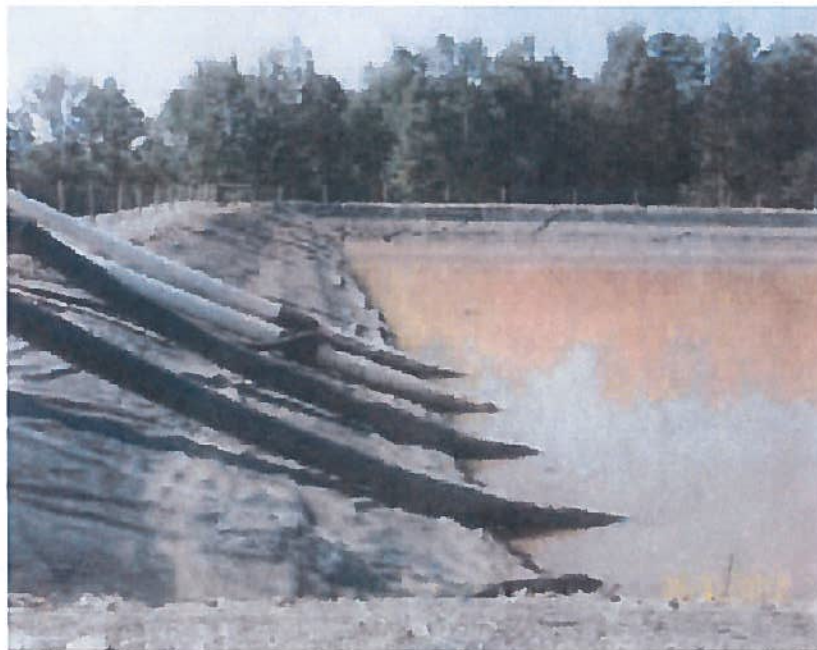
Photo of the S-Pit, showing flowback level, taken during the May 31, 2012 Inspection (Attachment 11).

Sampling of the S-Pit contents on May 10, 2012 indicated the presence of multiple volatile organic chemicals (VOCs) including: acetone (46.6 ug/l), bromoform (139 ug/l), bromomethane (6.1 ug/l), chlorodibromomethane (7.6 ug/l), chloroform (1.3 ug/l), and chloromethane (2.5 ug/l). Metals present in the samples included barium (2860 mg/l), calcium (4310 mg/l), copper (.13 mg/l), iron (6.2 mg/l), lithium (48.8 mg/l), magnesium (314 mg/l), manganese (.75 mg/l), sodium (12,600 mg/l), and strontium (983 mg/l). In addition, chlorides were present at a concentration of 35,100 mg/l and conductivity was approximately 100,000 us/cm. As acknowledged by EQT, conductivity is a useful screen for the presence of certain pollutants in flowback, including chloride, sulfate, sodium, magnesium, calcium, and iron. (Site

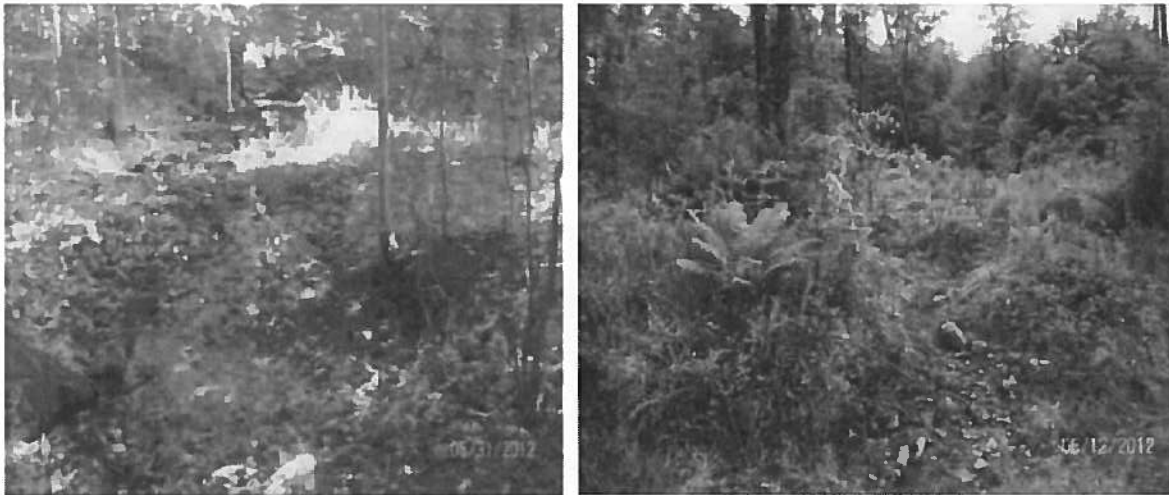
Photo on the left shows view of North Spring discharge looking downgradient (toward Rock Run), and also indicates where the spring surfaces (at the bottom of the photo), taken from the May 31, 2012 PA DEP inspection (Attachment 11). The photo on the right shows distressed vegetation and the flowpath of the S-Pit contents from the North Spring, taken during the June 12, 2012 PA DEP Inspection (Attachment 10).

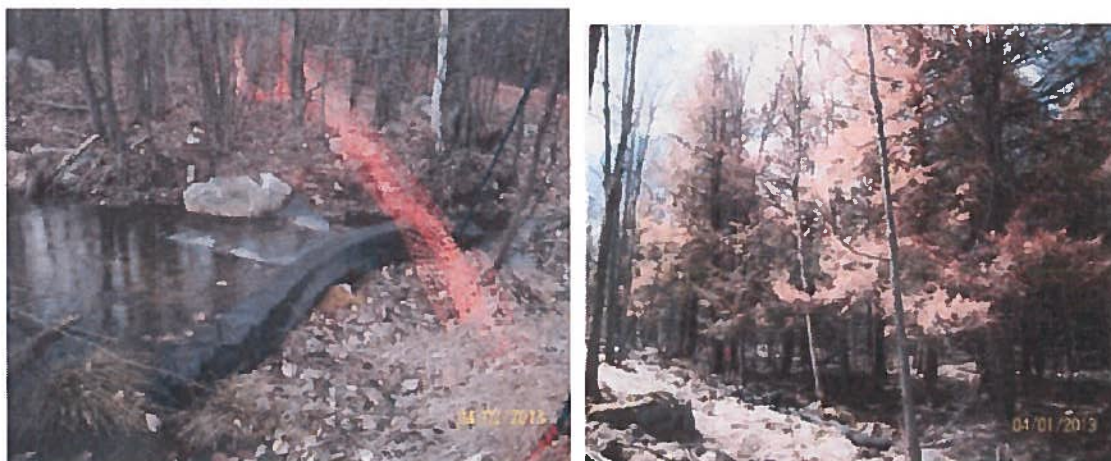
The photo on the left shows waste liner and "containment material" in the wetland beyond the NE corner of the well pad and the photo on the right shows stressed hemlocks adjacent to the "west trench area", both taken during the April 1, 2013 PA DEP Inspection (Attachment 31)

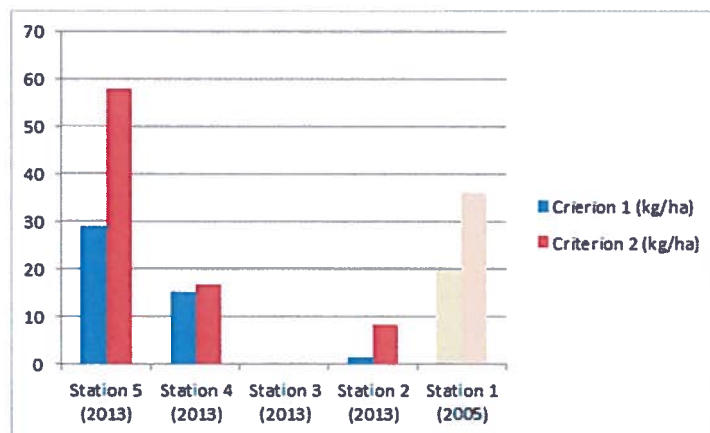
The fact that EQT is contemplating the cessation of voluntary control measures is concerning because its own data establishes the decline of aquatic health attributable to discharges to ground and surface water from its operations. For instance, with regard to the trout population, the data in the report establishes that although the sampling station (station 5) upstream of the tributary that carried EQT pollutants to Rock Run still qualifies, the four monitoring stations downstream no longer qualify for classification as a Class A Wild Trout Water based on PA DEP's criteria.⁵⁴ The chart below, created by EIP from data contained in the Normandeau report, demonstrates the decline in trout population from upstream to downstream of EQT's contamination.

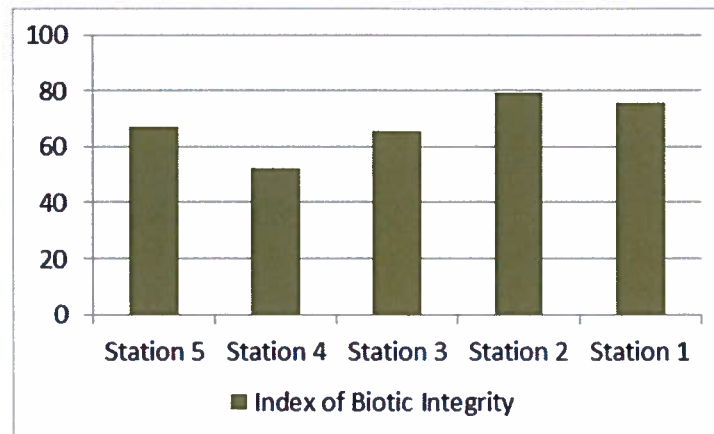
In addition, benthic macroinvertebrate sampling undertaken pursuant to Normandeau's evaluation establishes that the index of biological integrity scores declined from station 5 (upstream of EQT's contamination) to station 4 and then improved again at stations 3, 2, and 1. Station 4, immediately downstream of the tributary that carried EQT pollutants to Rock Run, currently qualifies as impaired. Id. at 11.

Chart created by EIP from data presented in the Normandeau report.

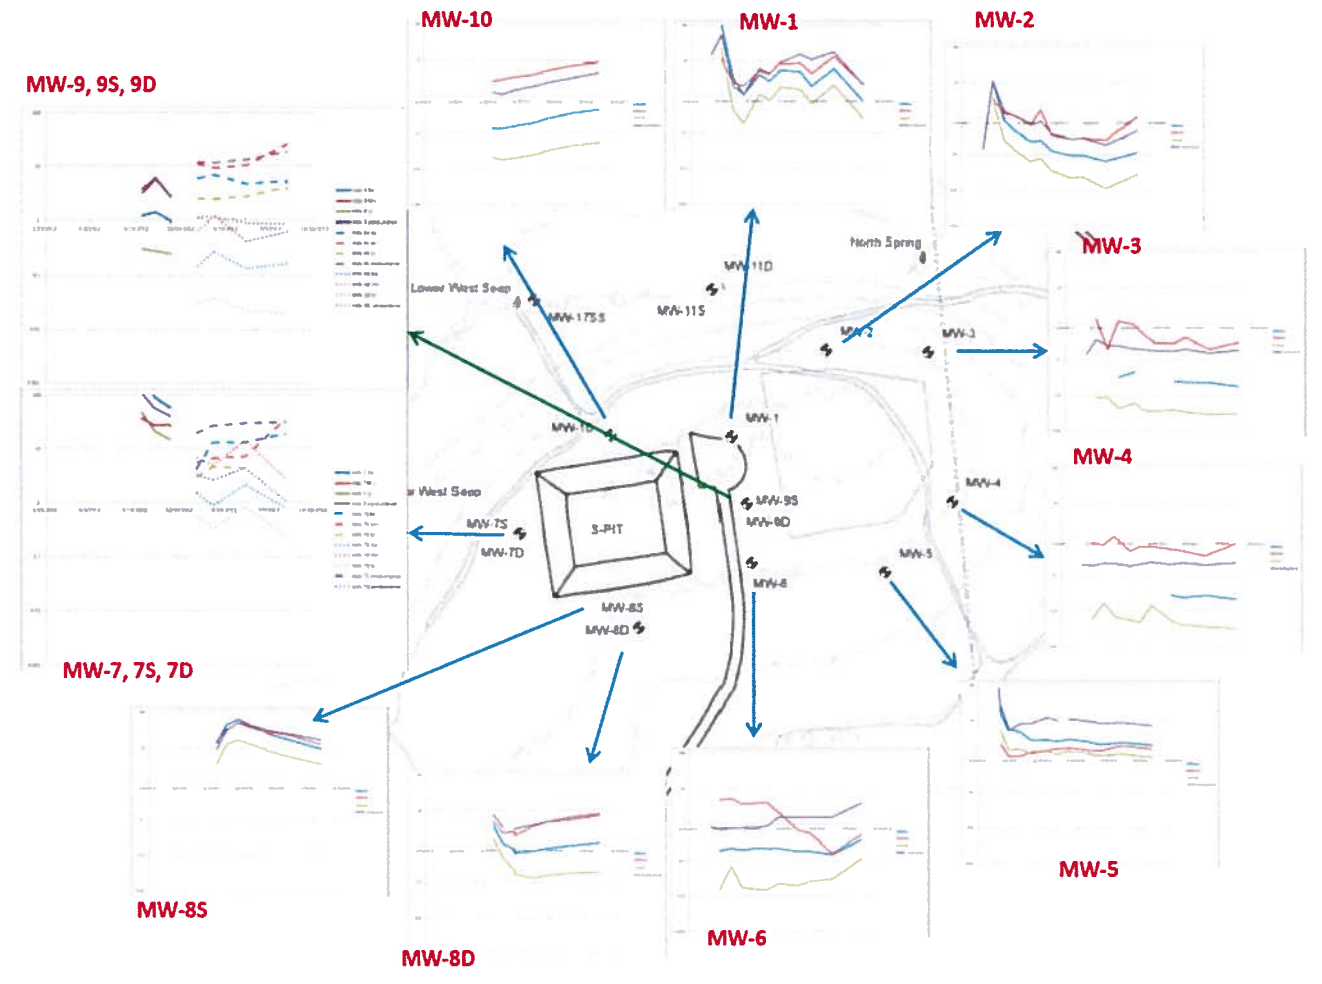
Map 4 (Contaminate Trends)*

* This map was prepared by EIP using EQT’s sampling data. See Monitoring Well tables, below. The four pollutants shown – barium, manganese, strontium, and conductance - were chosen due to their significance and correlation with each other. The trends were compared against groundwater standards for all pollutants except conductance (which was compared against a control concentration of 200 umhos/cm). The individual monitoring well maps were plotted using a log scale. As these trends indicate, reasonable concern exists regarding whether and to what extent the S-Pit continues to leach.

In addition, EIP has examined the groundwater data submitted by EQT to PA DEP. Based upon unsafe and increasing trends in some of the monitoring wells near the S-Pit, particularly wells 7, 9, and 10, we are concerned that the S-Pit continues to actively leach pollutants into groundwater. See Map 4 and Monitoring Well tables, below.
