November 19, 2019

RE: ***Notice of Intent to Sue Verso Corporation for Violations of the Resource Conservation and Recovery Act at the Luke Paper Company facility in Luke, Maryland***

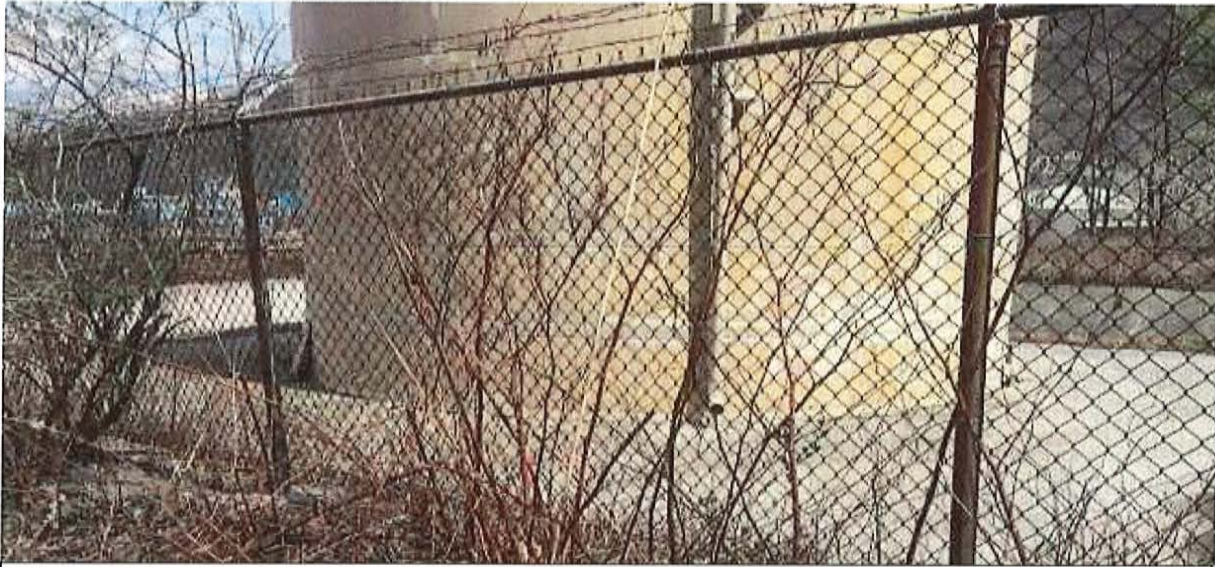
During operation, Luke Paper generated and stored black liquor, a byproduct in the paper pulping process, in the million-gallon storage tank.<sup>4</sup> According to the Environmental Manager at Verso Luke LLC, Ronald Paugh, the tank is empty and has not contained black liquor in over 15 years.<sup>5</sup>

Former million-gallon black liquor storage tank – Beryl, West Virginia.  
From MDE Black Liquid Inspection Report (April 9, 2019) (Attachment A).

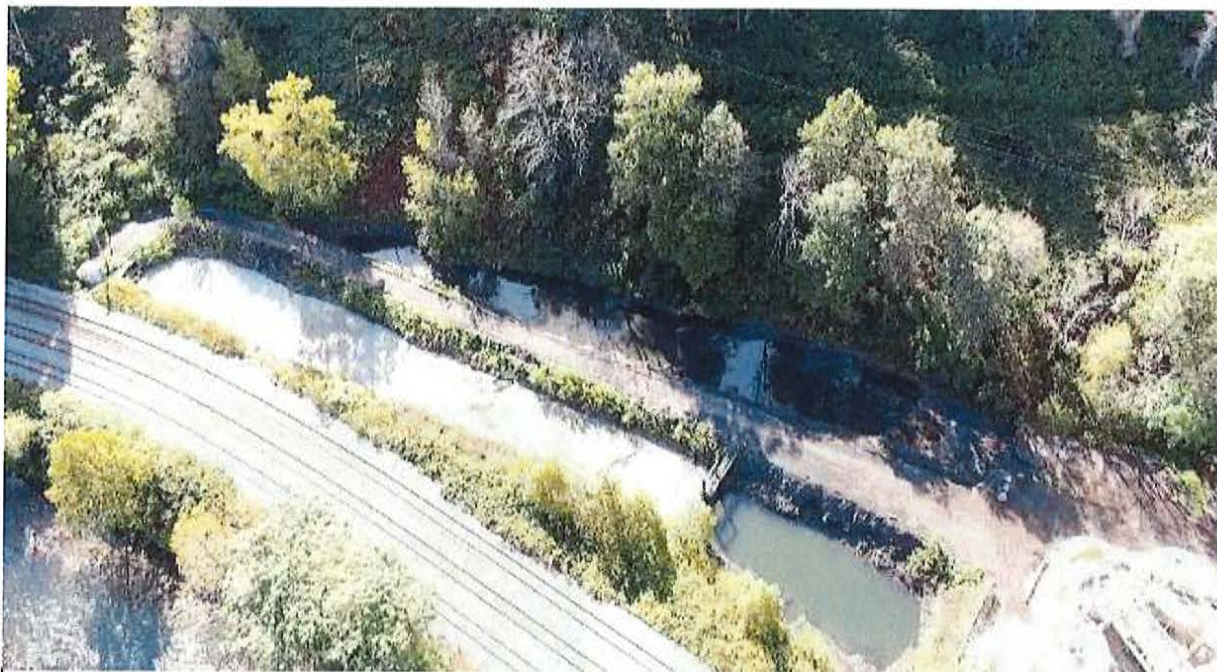
In addition to the million-gallon black liquor storage tank, there also is a coal ash pond onsite that, upon information and belief, is unlined. When the facility was operational, Luke Paper burned coal to produce energy and used the pond to dispose of the resulting coal combustion wastewater (herein "coal ash").<sup>17</sup> As EPA acknowledged in its October 2009 Steam Electric Power Generating Point Source Category: Final Detailed Study Report, "[m]any of the common pollutants found in coal combustion wastewater (e.g., selenium, mercury, and arsenic) are known to cause environmental harm and can potentially represent a human health risk."<sup>18</sup> According to the report, pollutants in coal ash are of "particular concern because they can occur in large quantities . . . and at high concentrations . . . in discharges and leachate to groundwater and surface waters."<sup>19</sup> In addition, some pollutants in coal ash present an increased ecological threat due to their tendency to persist in the environment and bioaccumulate, which often results in slow ecological recovery of organisms following exposure.<sup>20</sup>

Coal ash pond on West Virginia side of North Branch Potomac River.  
Photo taken by Brent Walls, Upper Potomac Riverkeeper, on September 9, 2019 by drone.

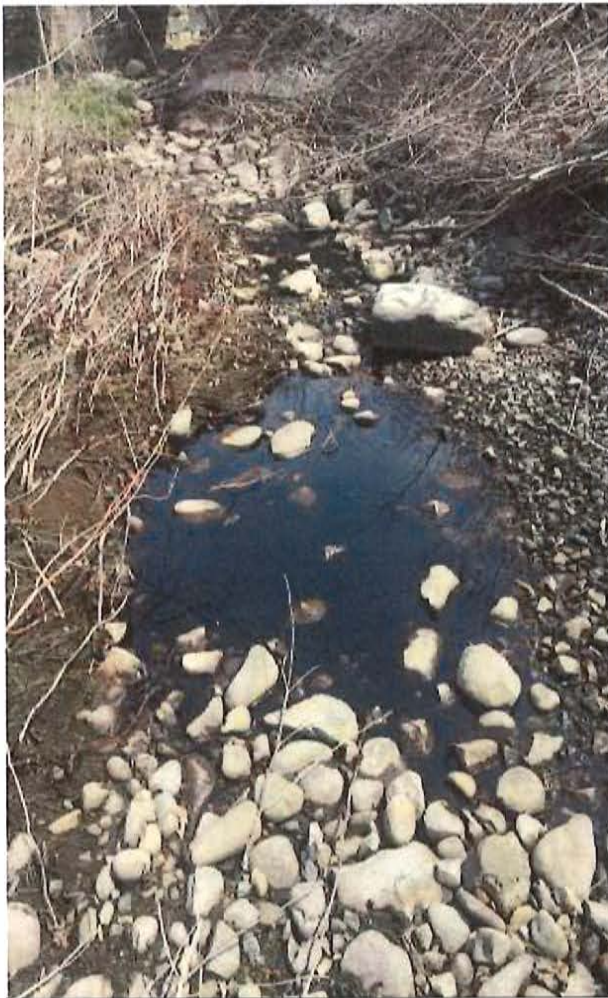
In response to a citizen complaint of pools of “pure black waste” on the West Virginia side of the River, MDE conducted an inspection on April 9, 2019.<sup>21</sup> The inspector observed that the black substance appeared to be seeping below the railroad mainline that bordered the River and settling in pools between rocks and the River.<sup>22</sup> He observed that some of the liquid was leaking into the River at the furthest downstream pool.<sup>23</sup> In one of the settling pools, the inspector took samples and measured pH and dissolved oxygen: 11.8 S.U. and 1.65 mg/L respectively. This pH measurement is consistent with the pH range of black liquor produced in the pulping process.<sup>24</sup> Below are two of the MDE inspector’s photographs from the April 9 site inspection.

Discoloration upstream of Railroad Crossing – West Virginia side of North Branch Potomac River  
From MDE Black Liquid Inspection Report (April 9, 2019) (Attachment A).

Based on the April 9, 2019 inspection, the MDE inspector advised Verso to: investigate the condition of the pipe that was once used to convey black liquor to the storage tank and determine if it had been separated and/or blanked; inspect the million-gallon storage tank for any remaining black liquor; determine the source of the black liquid; sample and test the waters for the presence of black liquor; and submit a follow-up report with findings.<sup>25</sup> Verso has likely been aware of the contamination for years and Environmental Manager Mr. Paugh noted that the contamination levels change based on the level of the River and water table.<sup>26</sup>

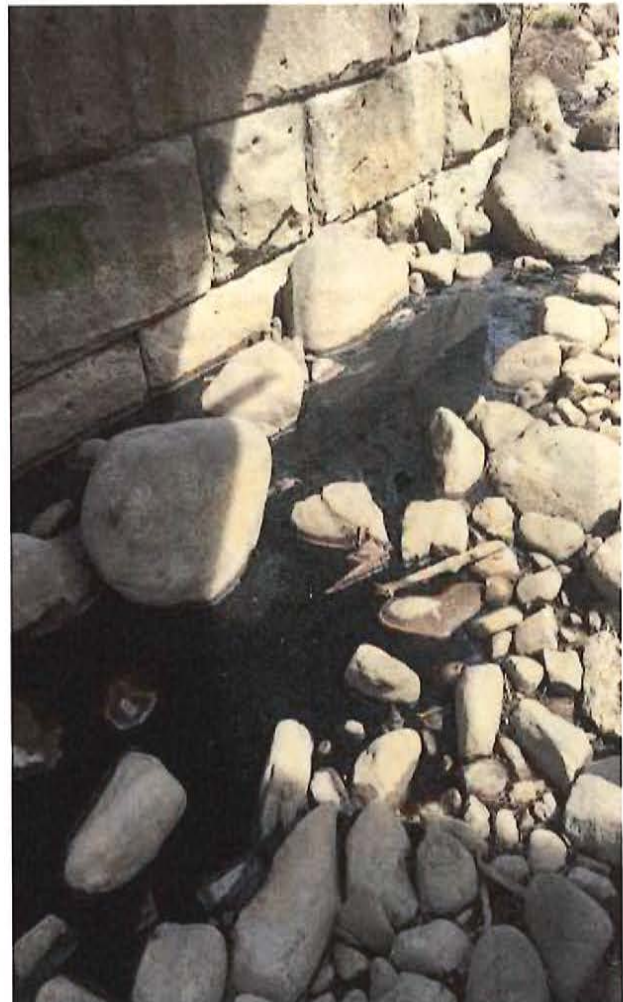
Discoloration at Railroad Crossing – West Virginia side of North Branch Potomac River  
From MDE Black Liquid Inspection Report (April 9, 2019) (Attachment A).

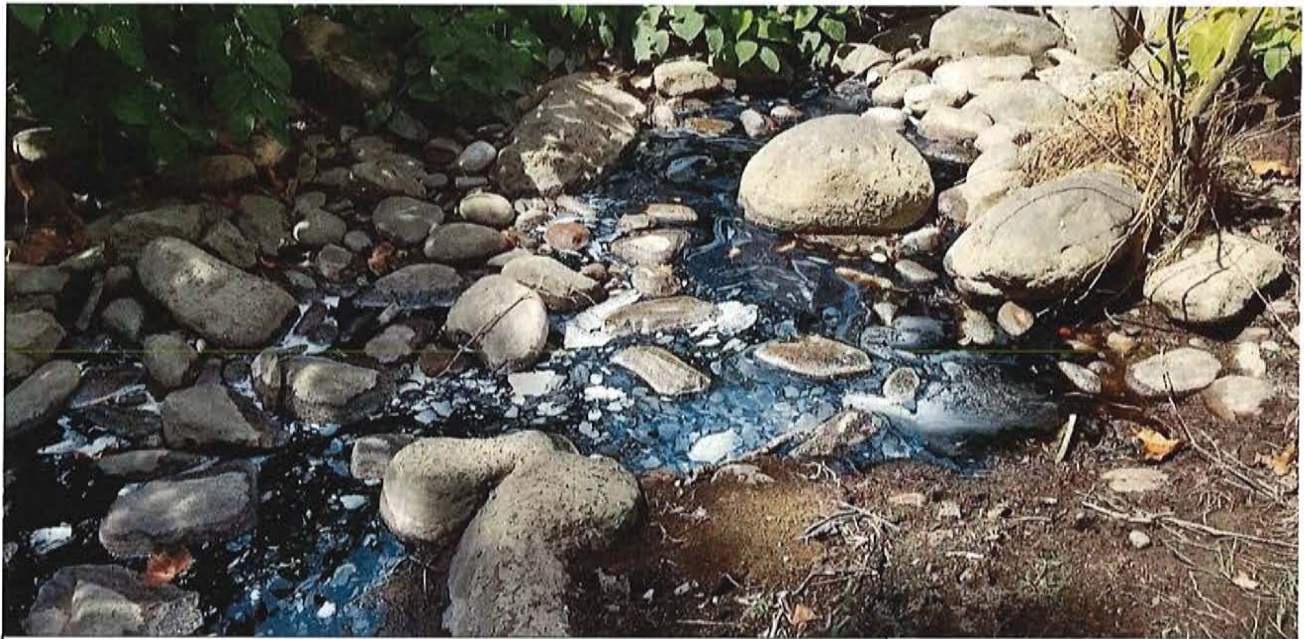
Finally, because the substance has already significantly discolored the water and changed the turbidity, as evident in the photo below, the environment has been and continues to be damaged aesthetically by the pollutants. Harm to the environment’s aesthetic value can be considered when determining whether activities constitute ISE.<sup>89</sup>

Photo taken by Brent Walls, Upper Potomac Riverkeeper, September 10, 2019.

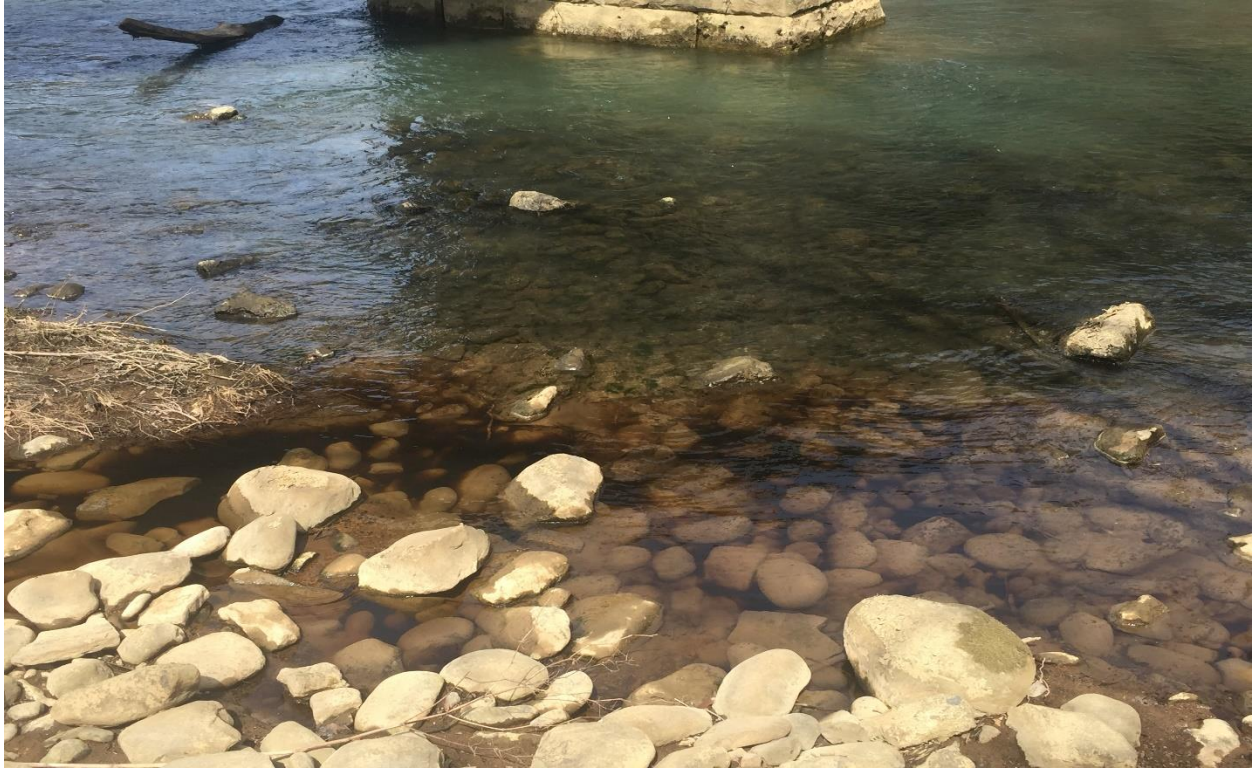
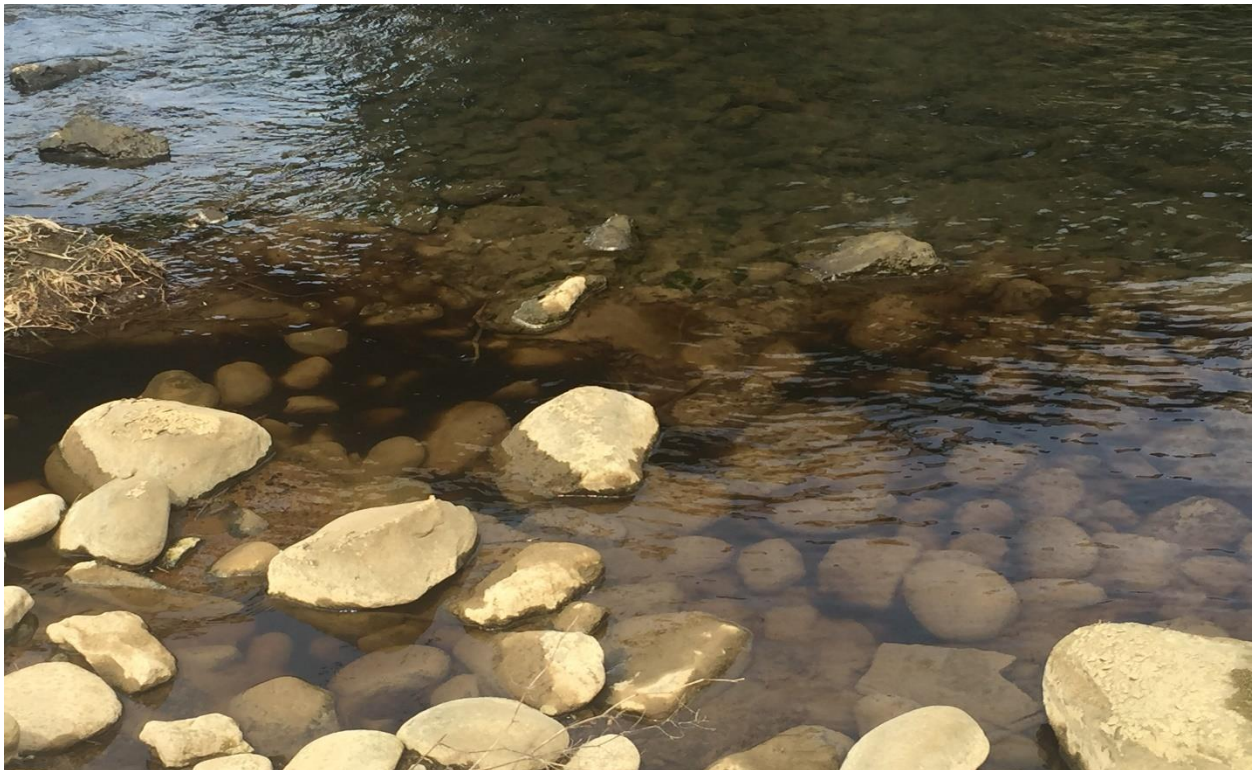
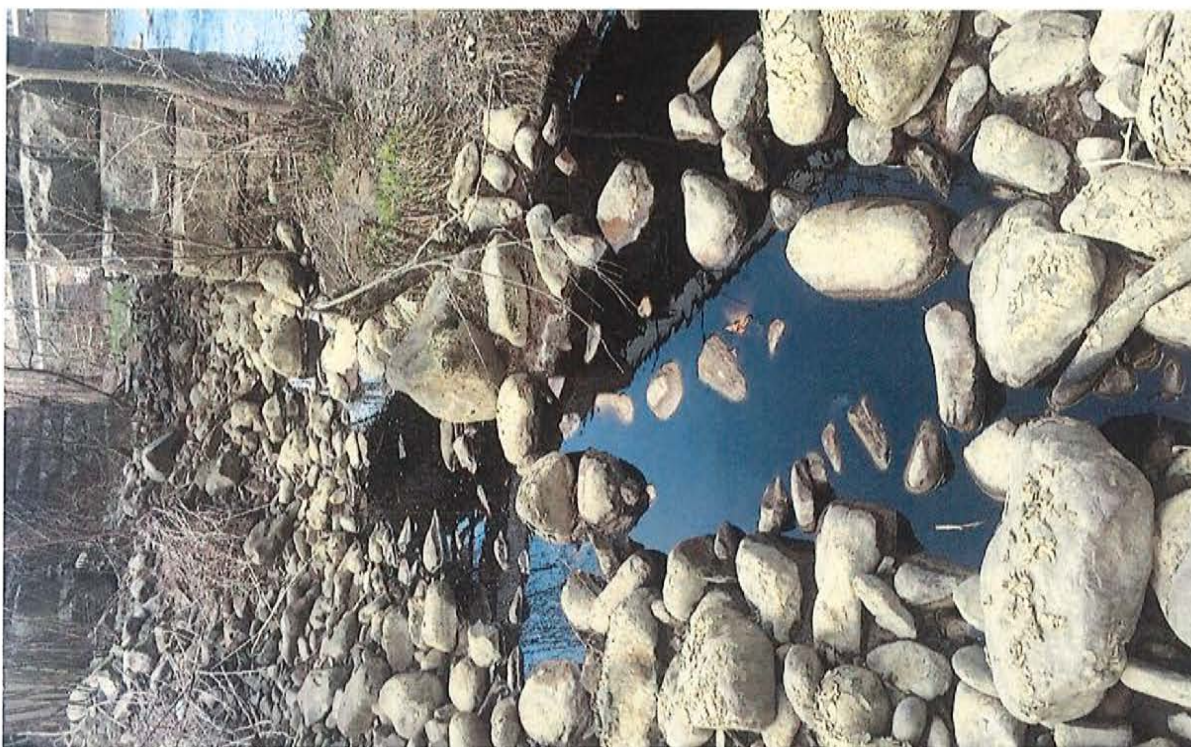
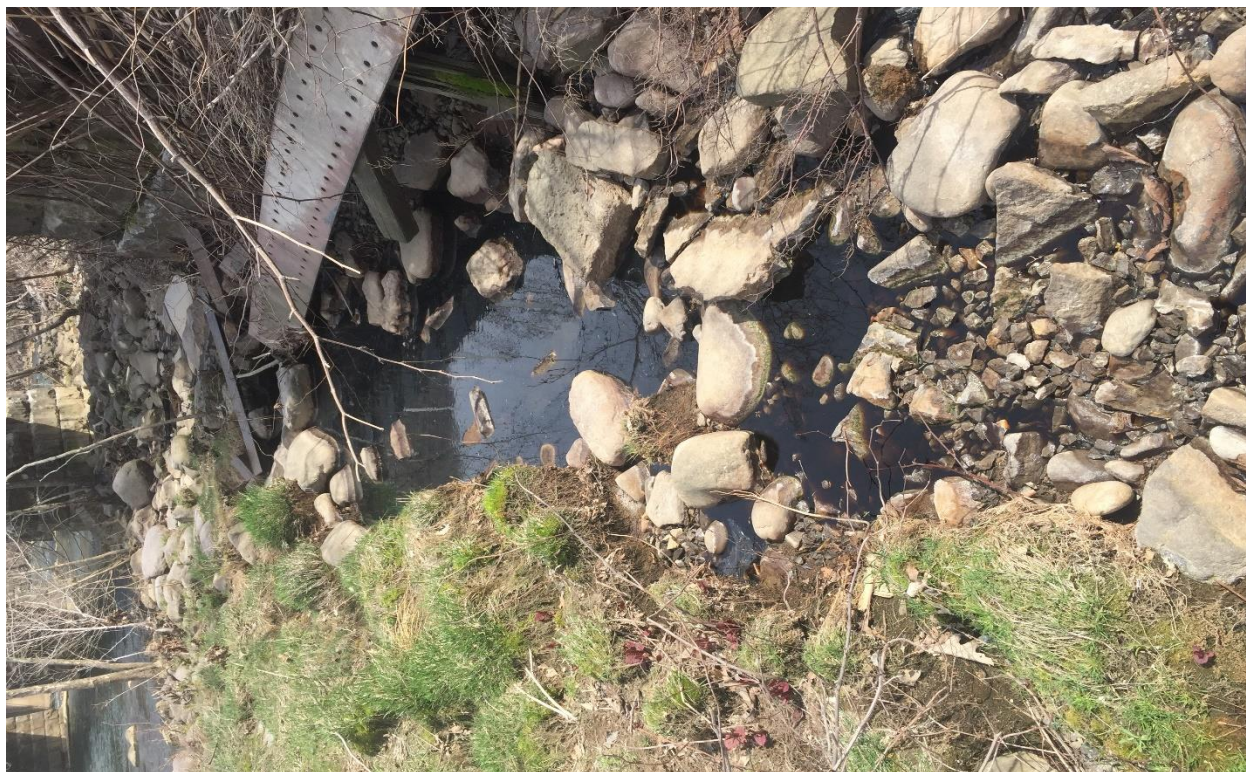
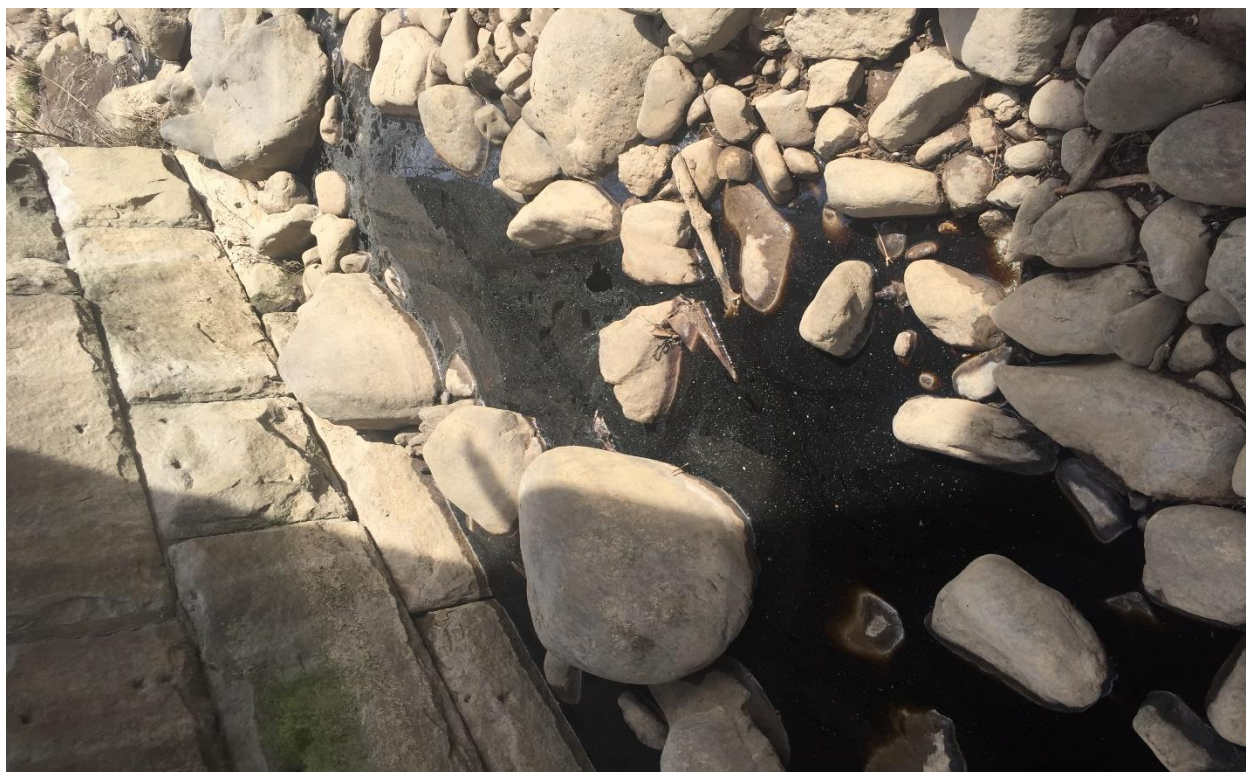
Stream Discoloration @ Railroad Crossing – West Virginia side of North Branch Potomac River

Discoloration @ Railroad Crossing – West Virginia side of North Branch Potomac River

Discoloration looking downstream at Railroad Crossing – West Virginia side of Potomac River

Discoloration at Railroad Crossing – West Virginia side of North Branch Potomac River

1. Investigate the condition of the pipe once used to transfer black liquor to the storage tank located in Beryl, West Virginia.
2. Inspect the Million Gallon storage tank for any remaining black liquor.
3. Determine the source of the liquid observed during today's investigation.
4. Determine if the pipe used to transfer black liquor has been separated and/or blanked.
5. Sample and test the waters observed during this investigation for the presence of black liquor. Testing should be performed by a qualified and certified independent laboratory.
6. Submit a follow-up report with findings of your investigation.

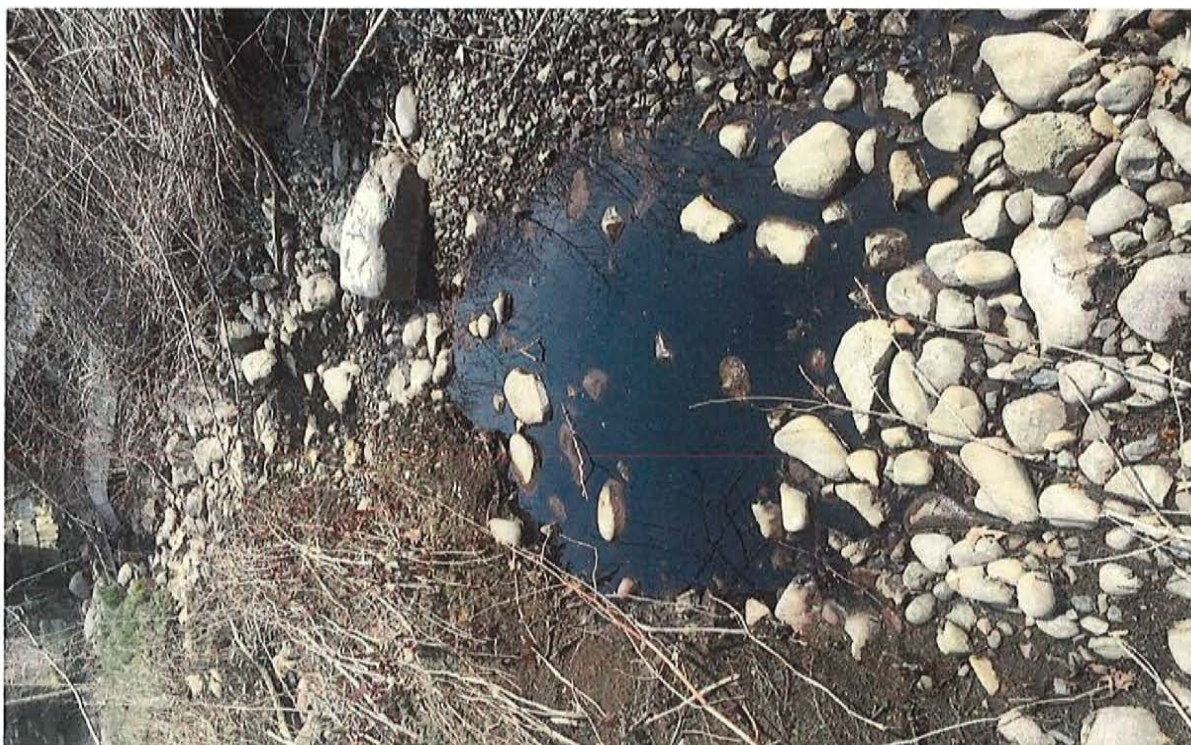
Discoloration Upstream of Railroad Crossing – West Virginia side of North Branch Potomac River

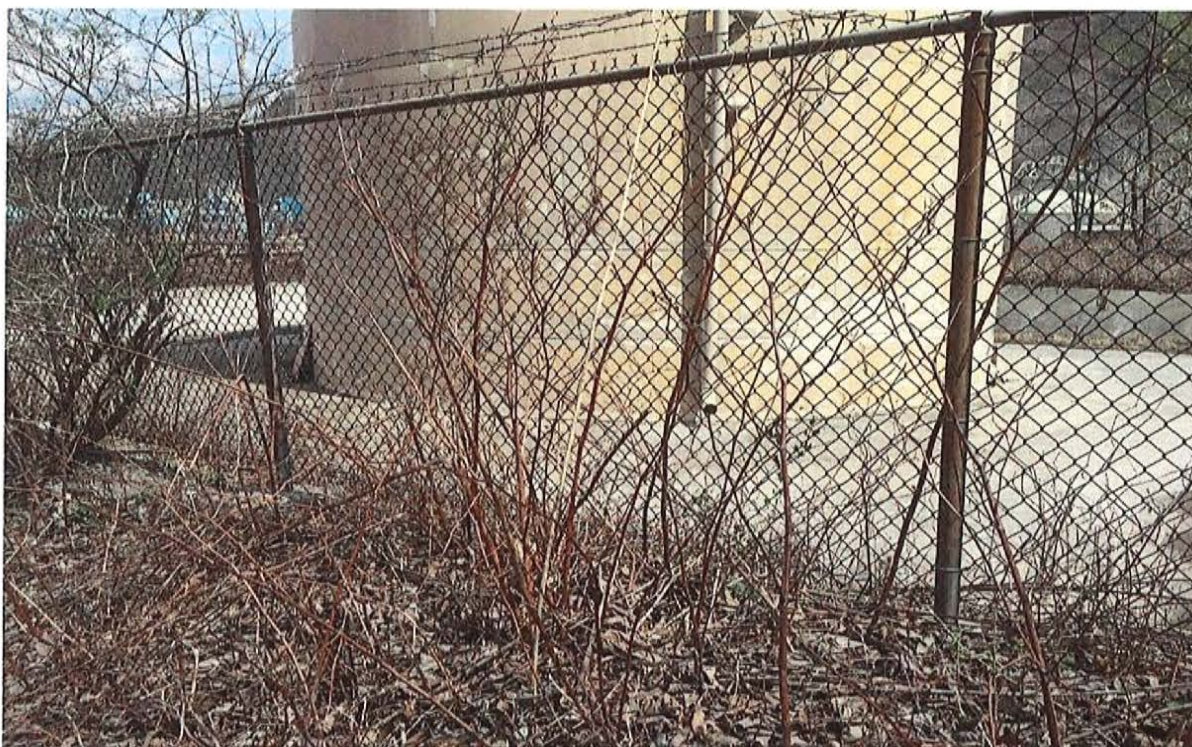
Former Million Gallon Black Liquor Storage Tank – Beryl, West Virginia

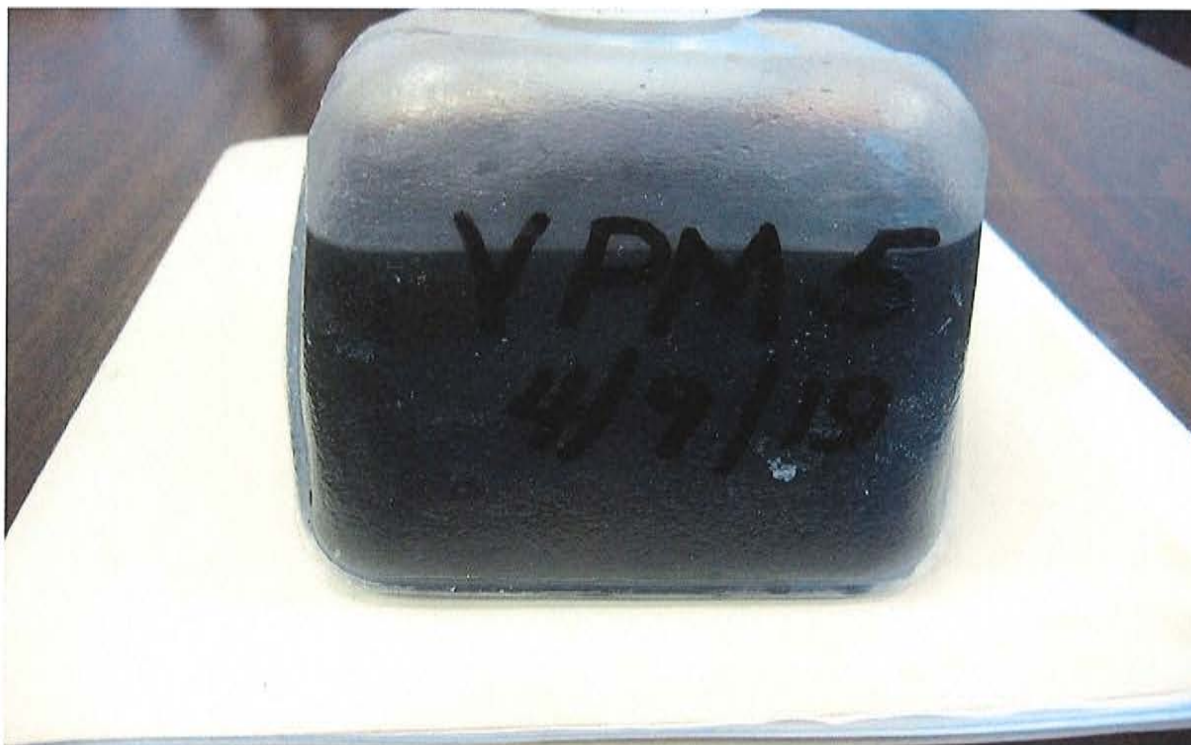
Samples Collected from Potomac River @ Beryl, West Virginia

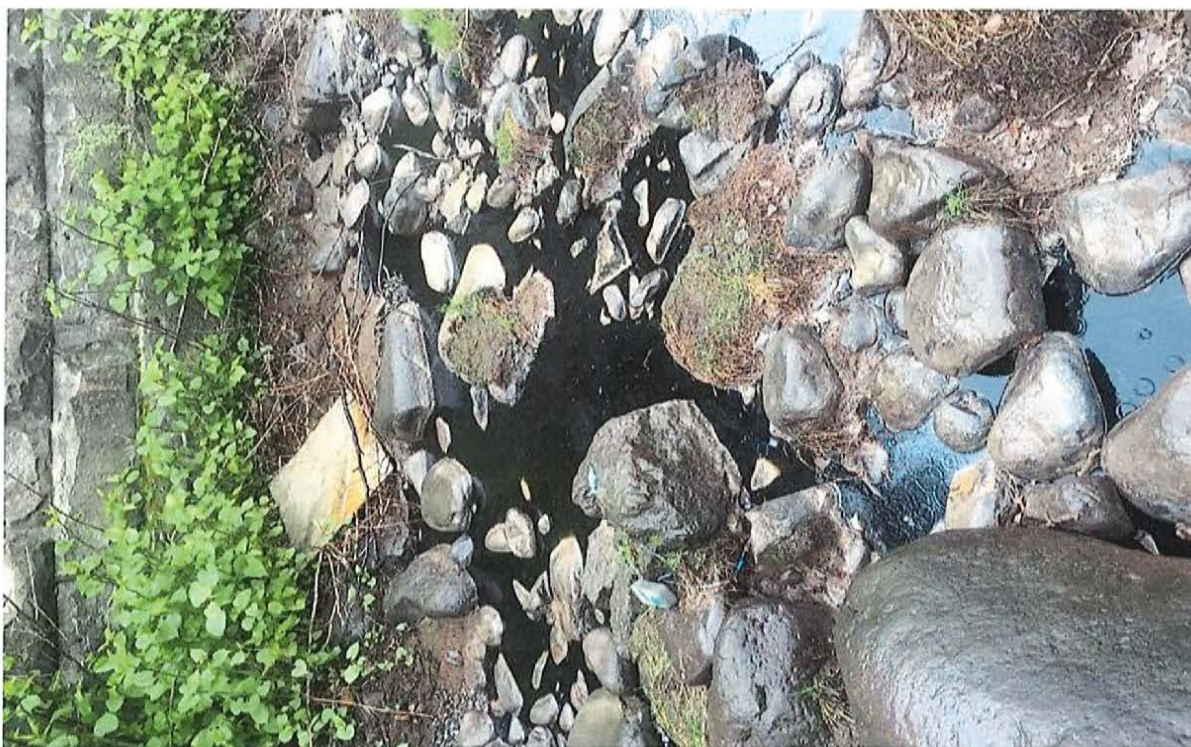
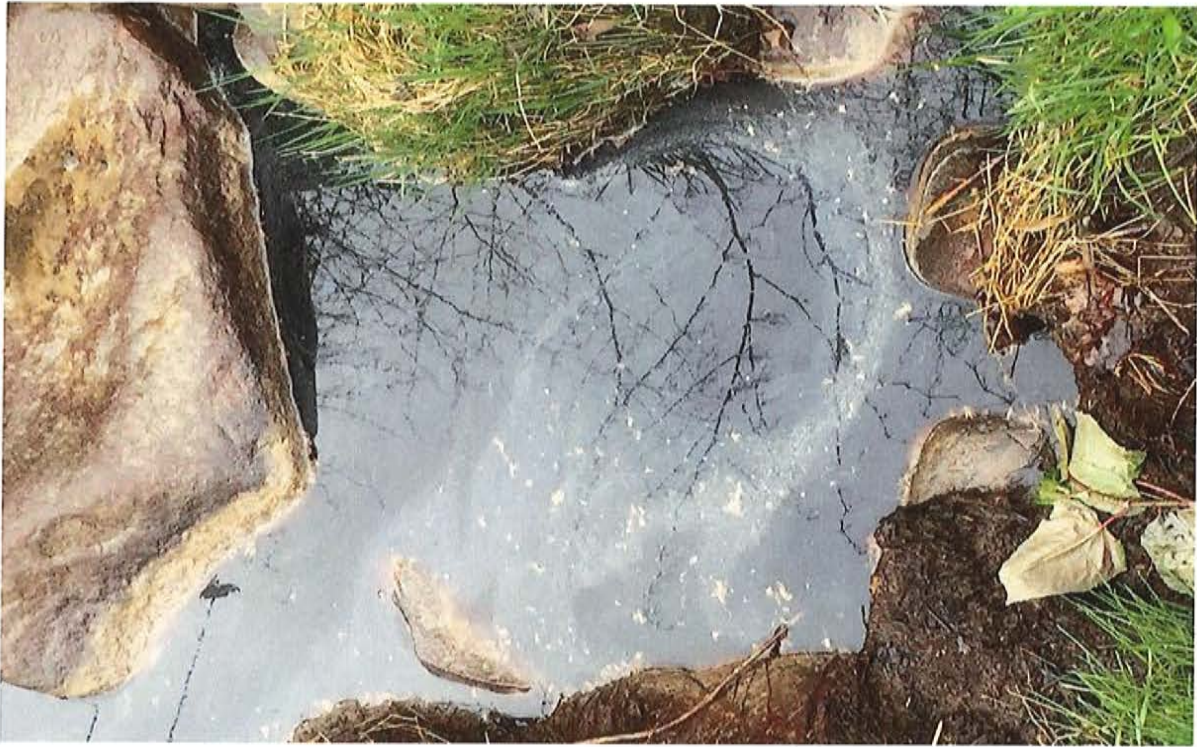
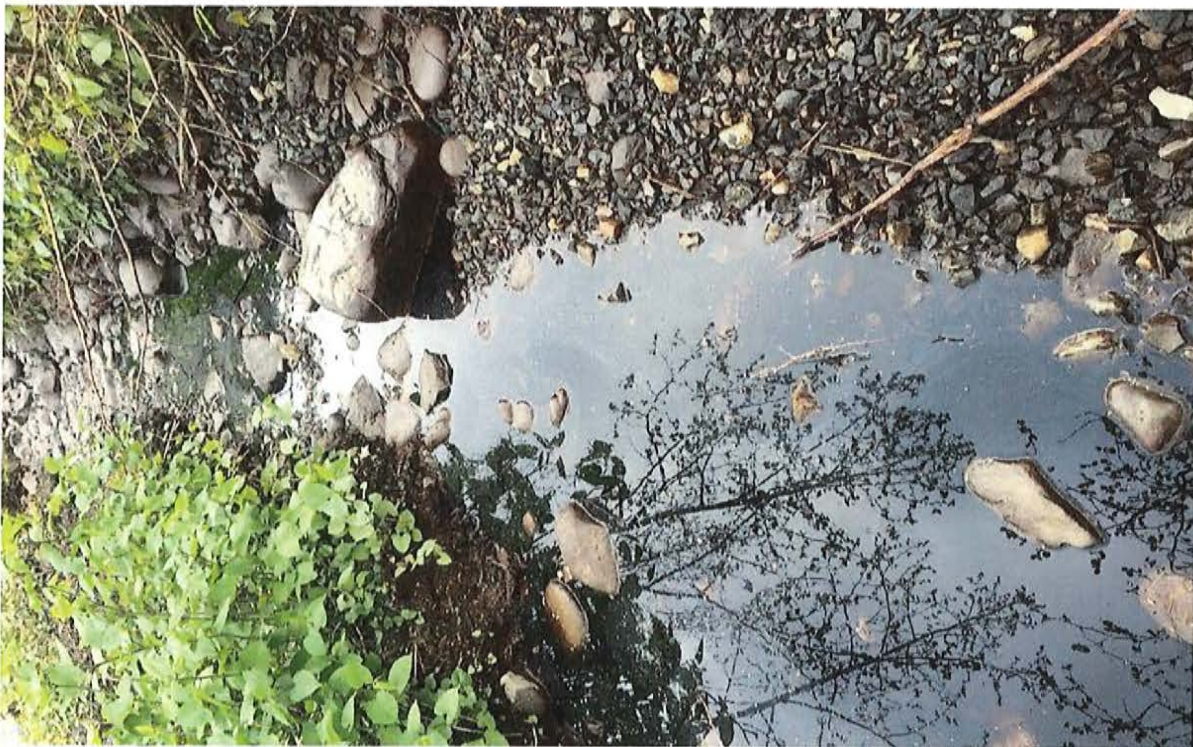
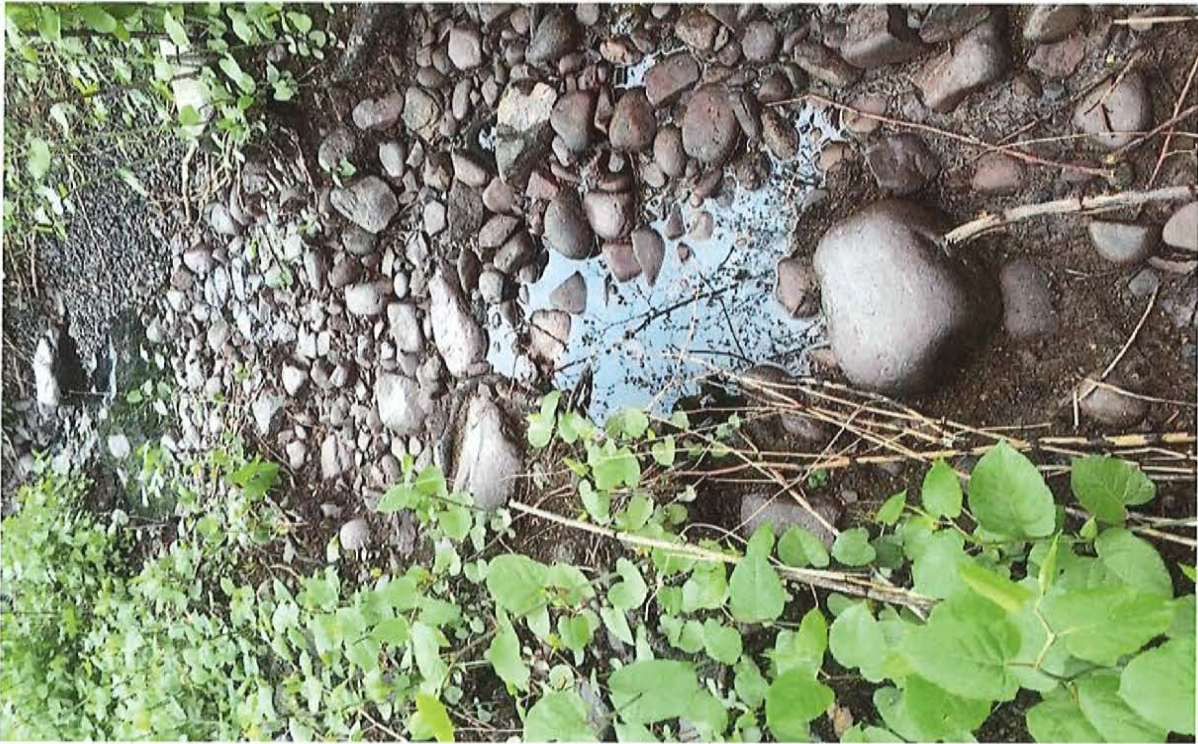
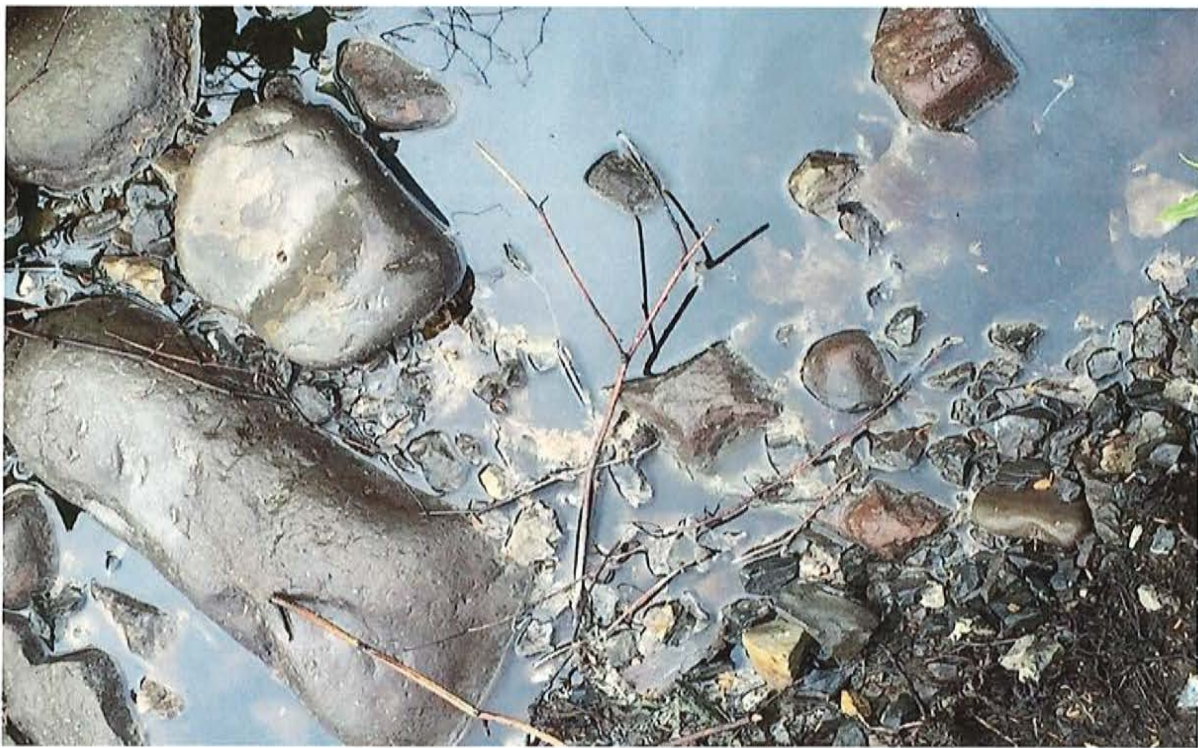
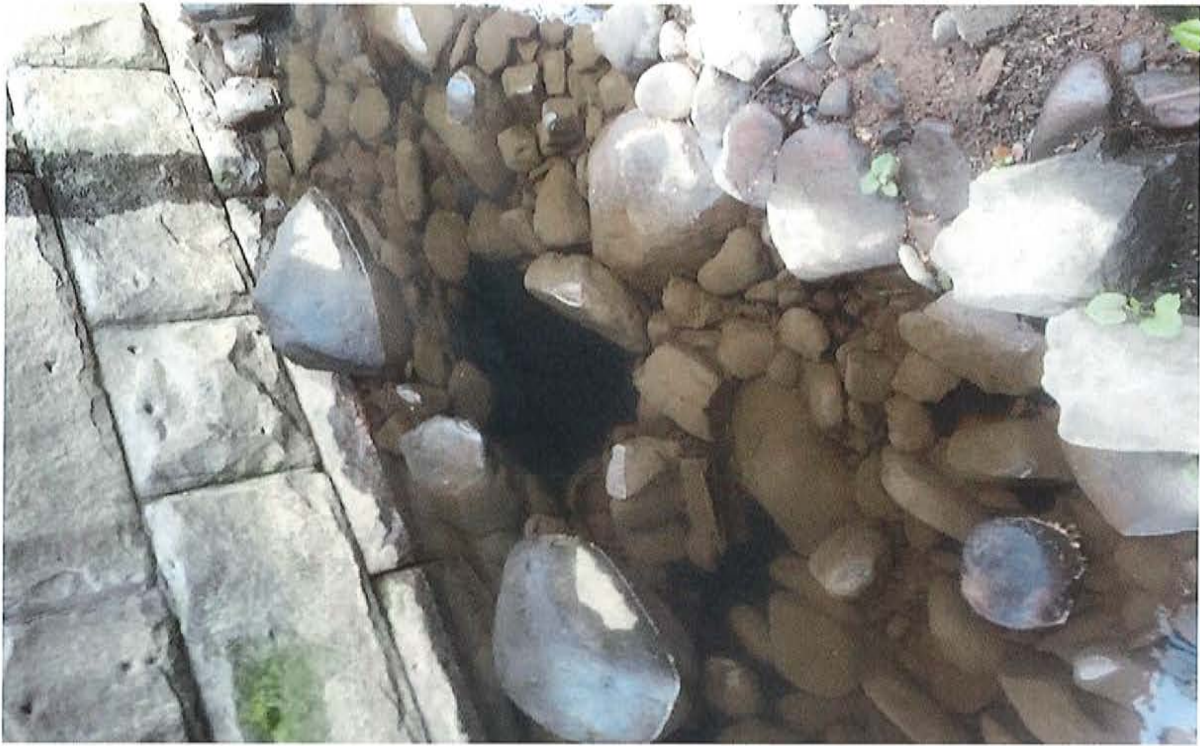
I arrived at the Verso Mill after contacting Verso's Environmental Manager, Ron Paugh. Together Mr. Paugh and Larry Johnson of the Verso Mill traveled to the location along the River in West Virginia to collect samples. Samples were collected in bottles prepared by MDE's contract laboratory and transferred to a cooler in ice. Although two of the furthest downstream pools appeared to be clearing, the remaining upstream pools remained dark and discolored as was observed during my earlier investigation. Again the dark discolored waters appeared to be seeping from under the

Discoloration @ Railroad Crossing – West Virginia side of North Branch Potomac River

1. Determine the source of the liquid observed during today's investigation.
2. Sample and test the waters observed during this investigation for the presence of black liquor. Testing should be performed by a qualified and certified independent laboratory. The results need to be forwarded to MDE.
3. As soon as possible, investigate and implement with MDE's approval, a procedure to contain and remove the unauthorized discharge in an environmental acceptable manner.
4. Within thirty(30) days following receipt of this report, submit a follow-up report with findings of your investigation, the source, and a plan of action to address and eliminate the unauthorized discharge.

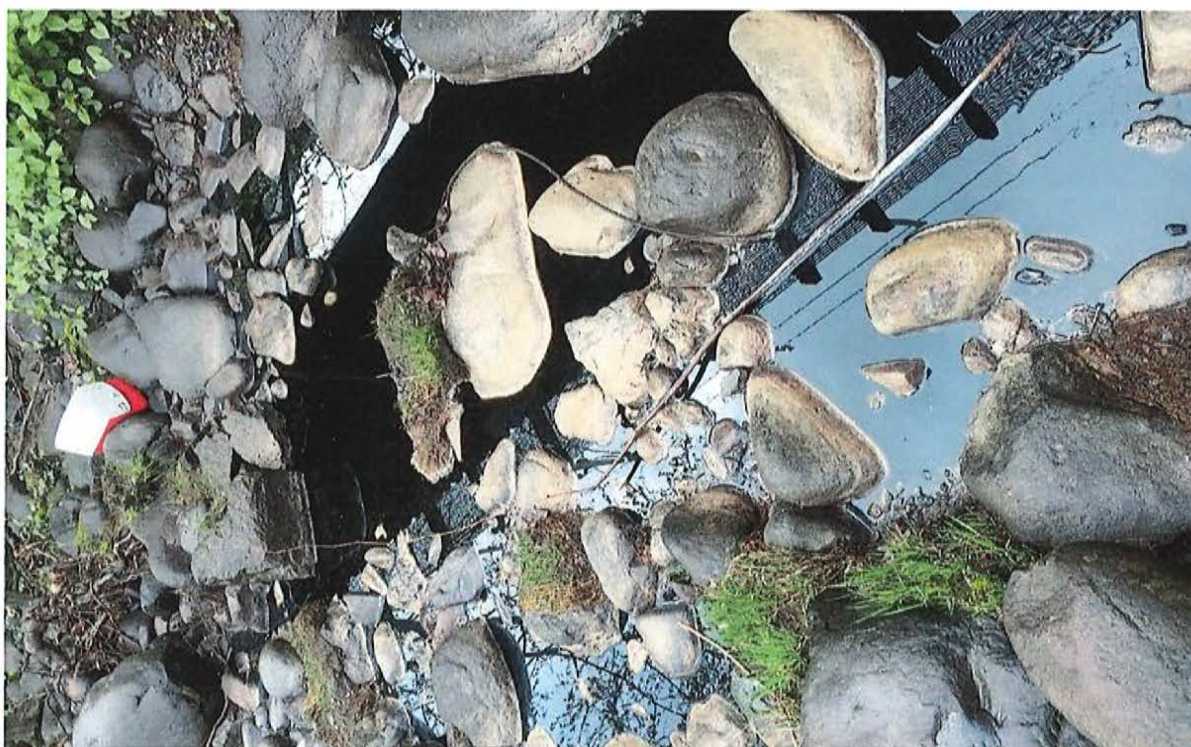
Sampling Location @ Railroad Crossing – West Virginia side of North Branch Potomac River

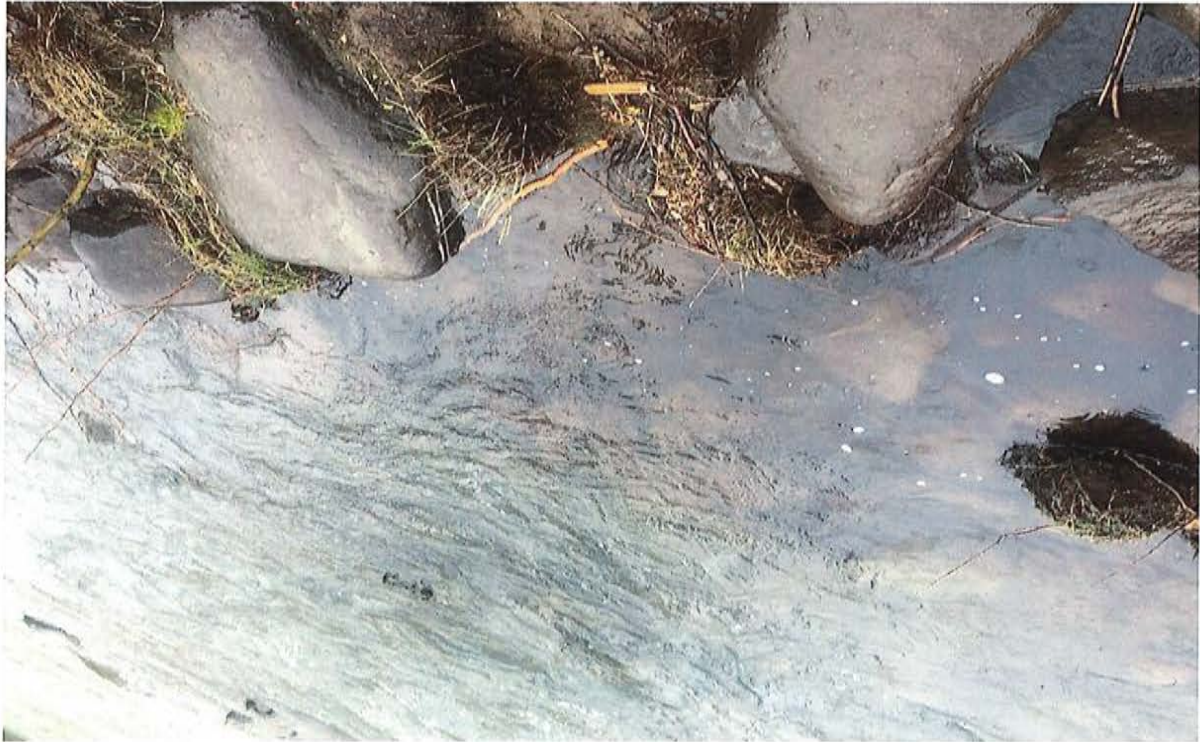
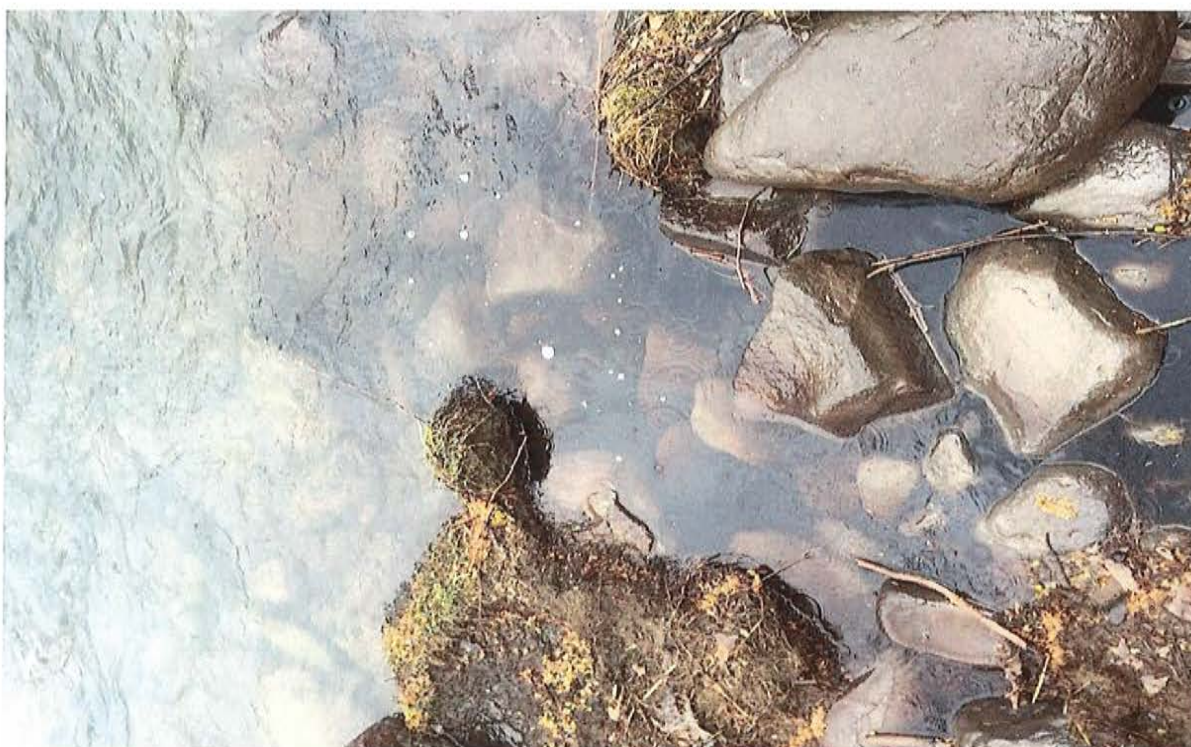
Discoloration @ River's Edge – West Virginia side of North Branch Potomac River

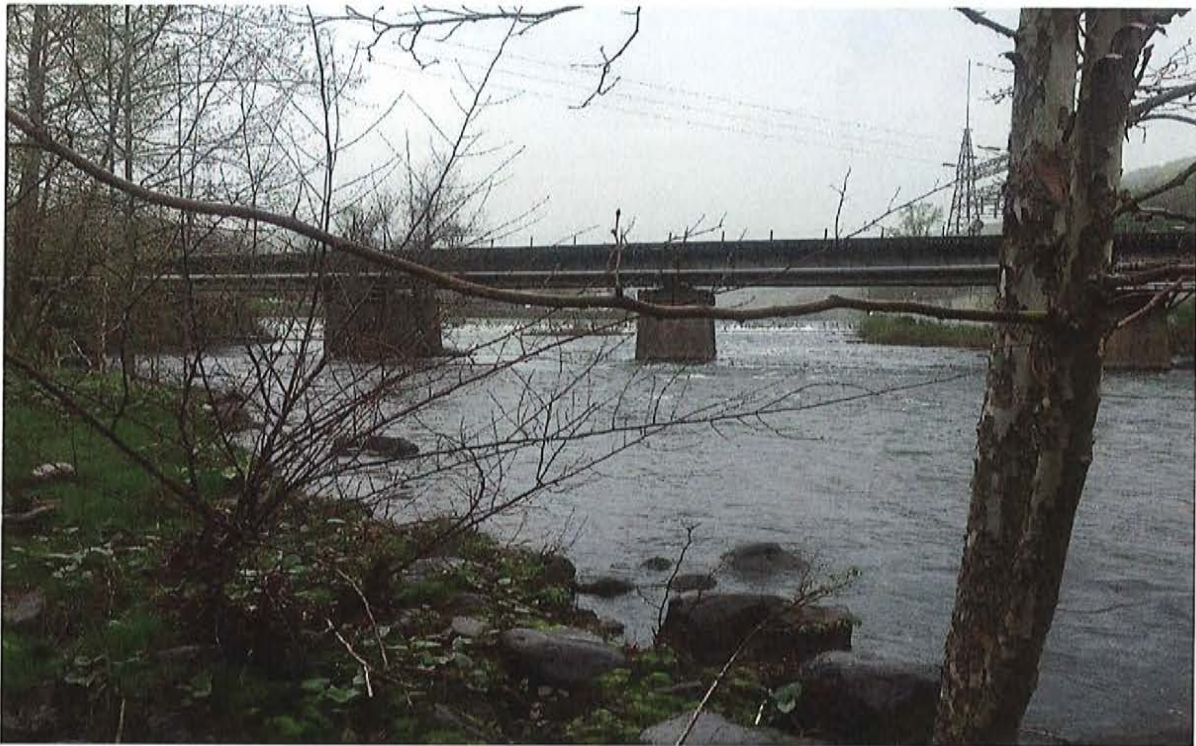
Sampling Location West Virginia Side North Branch Potomac River Looking Upstream

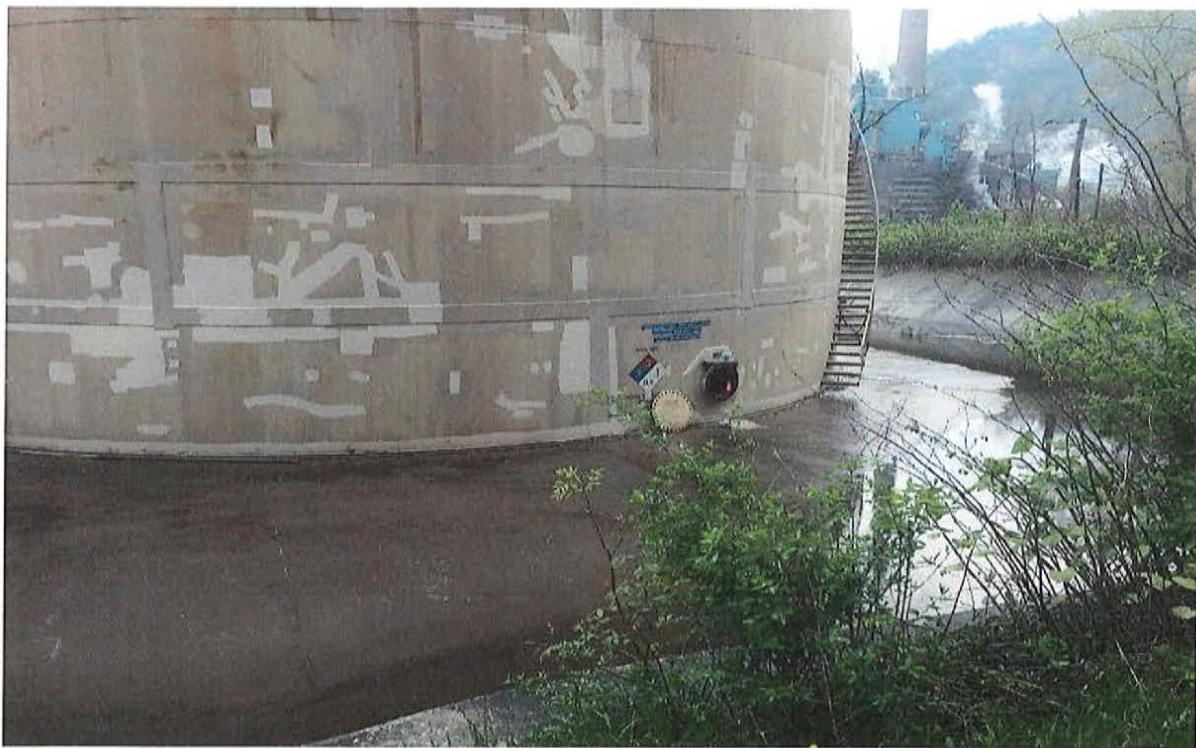
Former Million Gallon Storage Tank with Containment

Former Million Gallon Storage Tank
