November 19, 2019

RE: ***Notice of Intent to Sue Verso Corporation for Violations of the Resource Conservation and Recovery Act at the Luke Paper Company facility in Luke, Maryland***

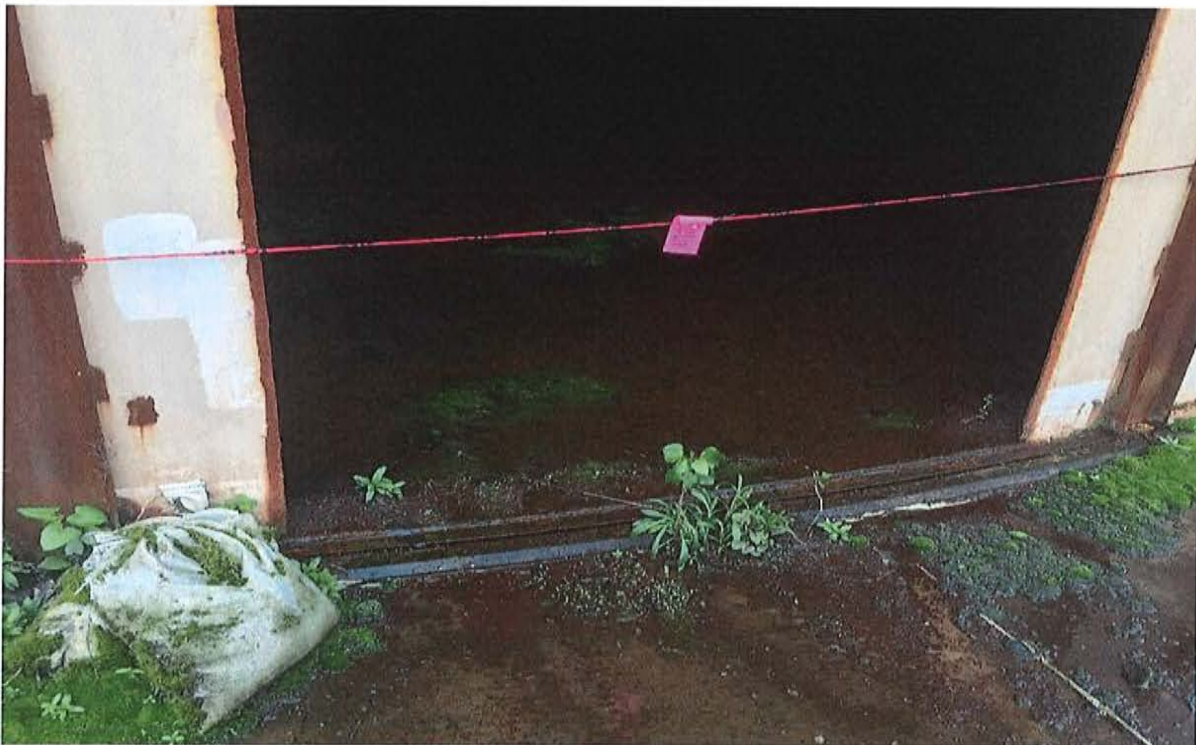
Breached Million Gallon Storage Tank

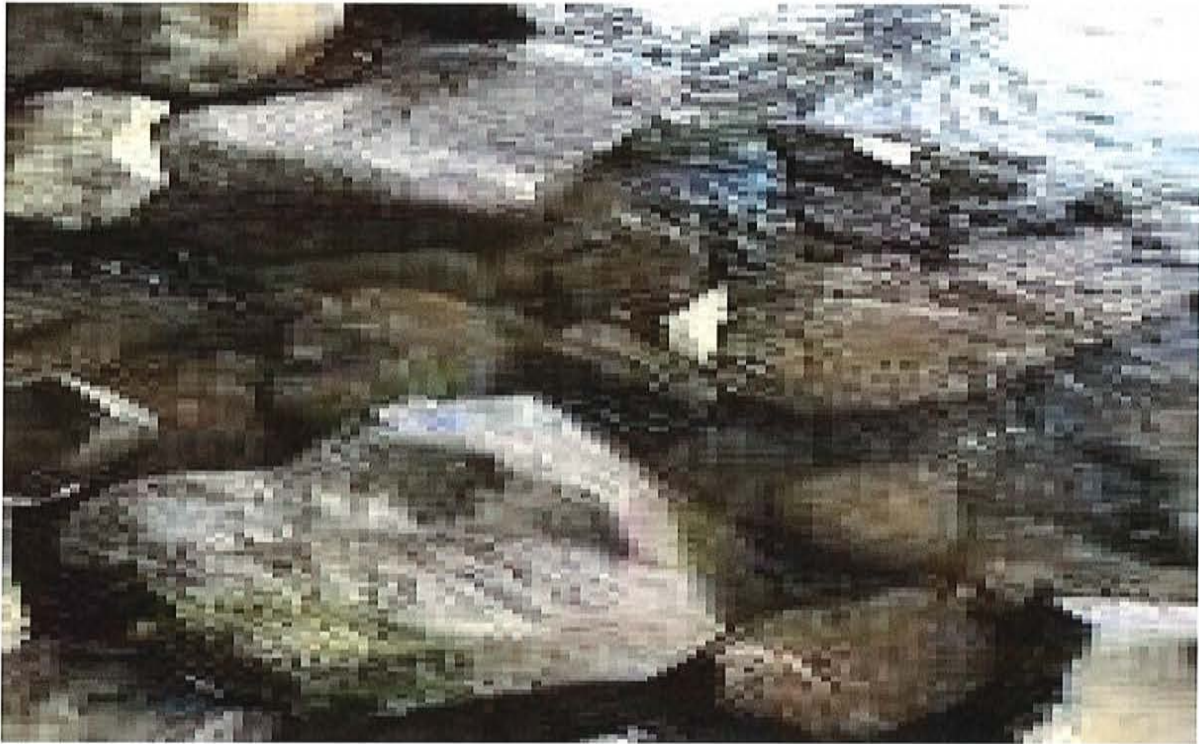
Dead Fish(Trout) North Branch Potomac River – June 29, 2019 @ Beryl, West Virginia
